4THRUGHT PROPERTY INSPECTIONS

RESIDENTIAL INSPECTION

1234 Main St. Lakewood CO 80226

05/08/2022 9:00AM

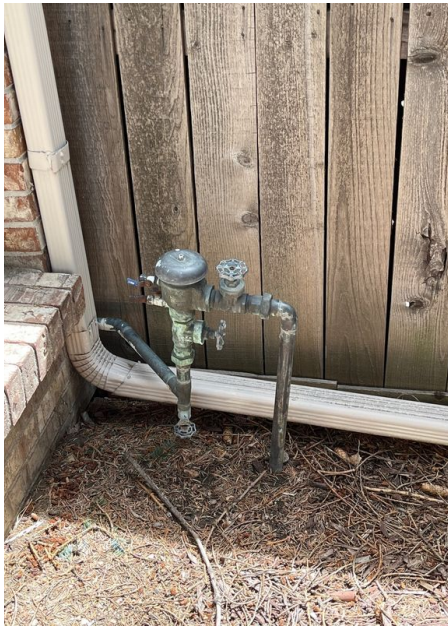
Grading & Landscaping: Irrigation System Winterized

The irrigation system was depressurized and winterized upon arrival at the subject property and the valve remained shut throughout the course of this inspection. The system was neither operated or inspected, and the valve lineup remained unchanged during this inspection.

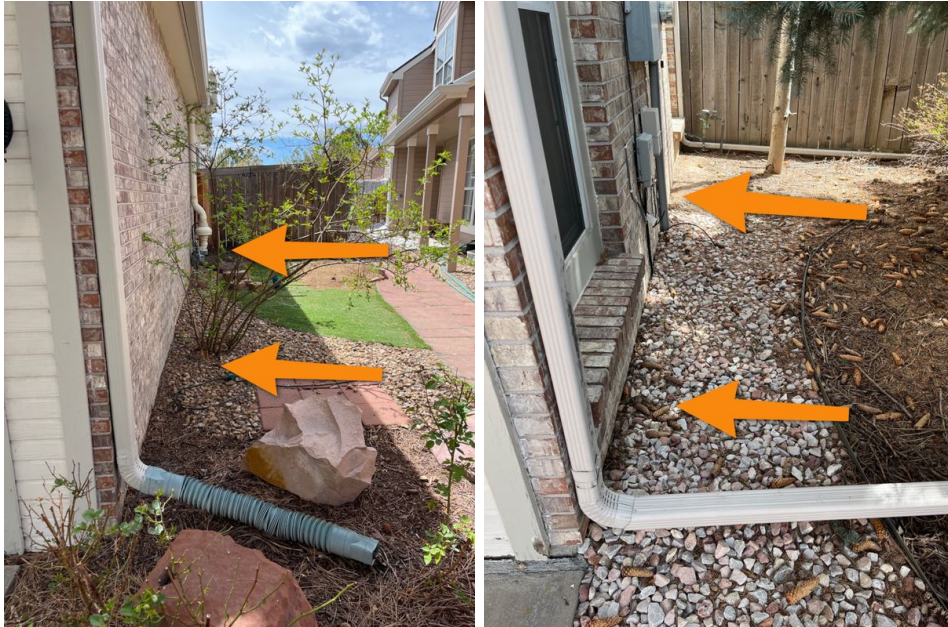
2.1.2 Grading & Landscaping

Monitor drainage around structure, landscape is level to negative in areas, potential for water entry to foundation and structure. Regrade as needed to move water away.

Contact a qualified grading contractor.

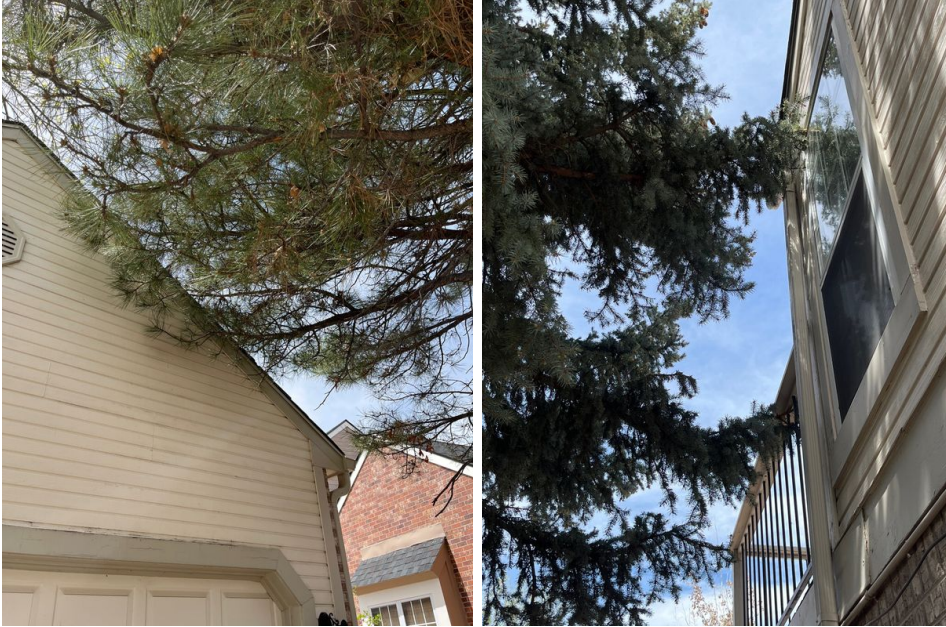
2.1.3 Grading & Landscaping

Trees, bushes and/or other landscaping are contacting the structure. Recommend trimming all vegetation at least 36" away from the structure to improve siding/roof longevity and minimize damage to the structure.

Contact a qualified landscaping contractor

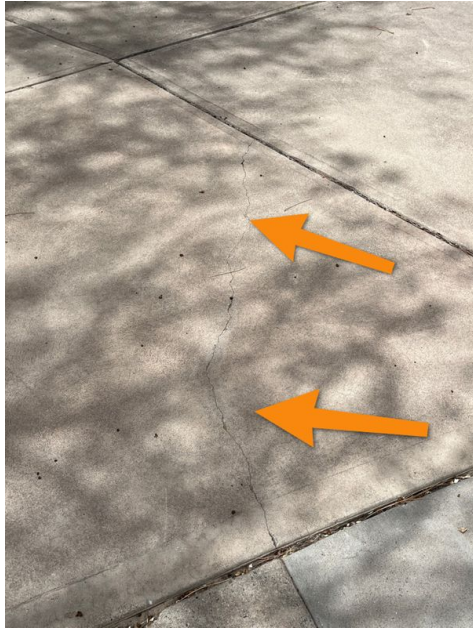
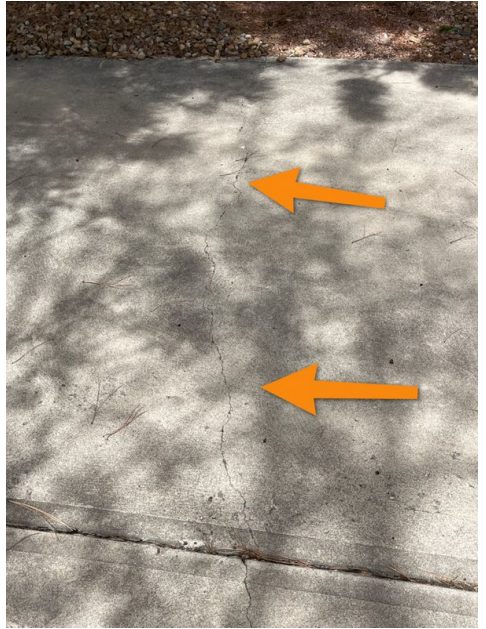
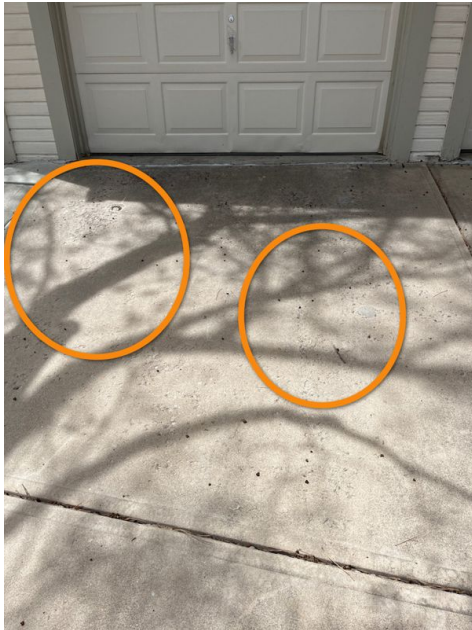
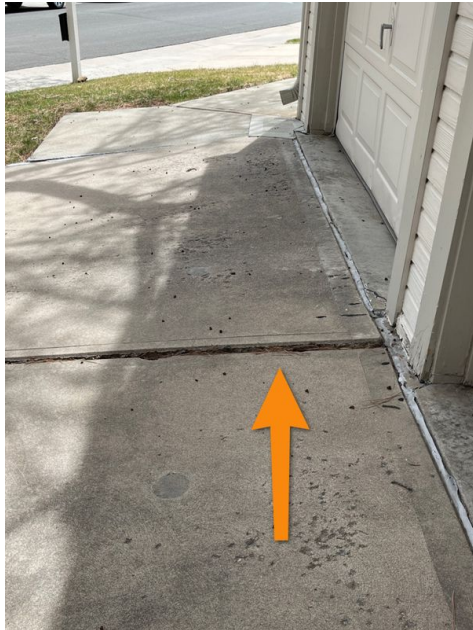
2.2.2 Driveways & Walkways

MUD JACKING EVIDENT

Recommendation

Contact a qualified concrete contractor.

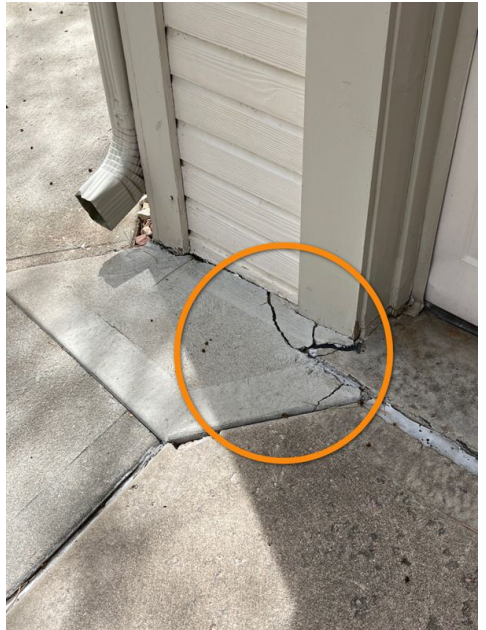
2.2.1 Driveways & Walkways

DRIVEWAY DETERIORATION

Notable deterioration, spalling and cracking noted in driveway concrete. Seal cracks to prevent further movement and water intrusion. Recommend having a qualified contractor inspect concrete flatwork system, advise and correct or replace as necessary.

Contact a qualified concrete contractor.

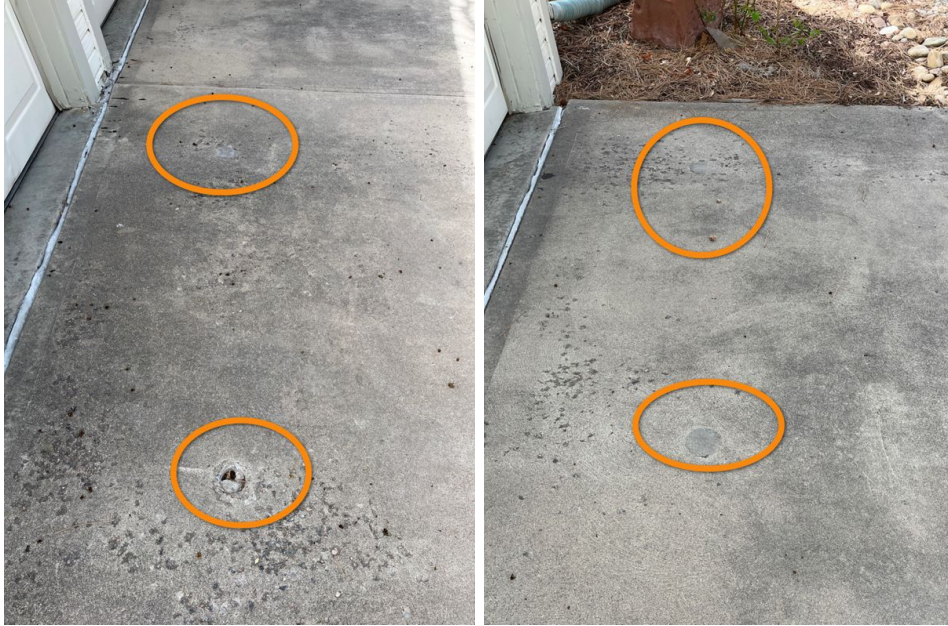
Mud jacking evident throughout concrete flatwork system. Recommend check with seller or property owner as to past history of sinking concrete and methods used to repair.

Contact a qualified concrete contractor.

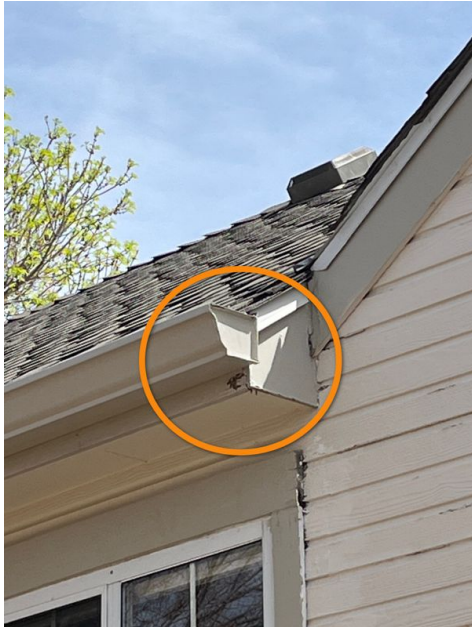
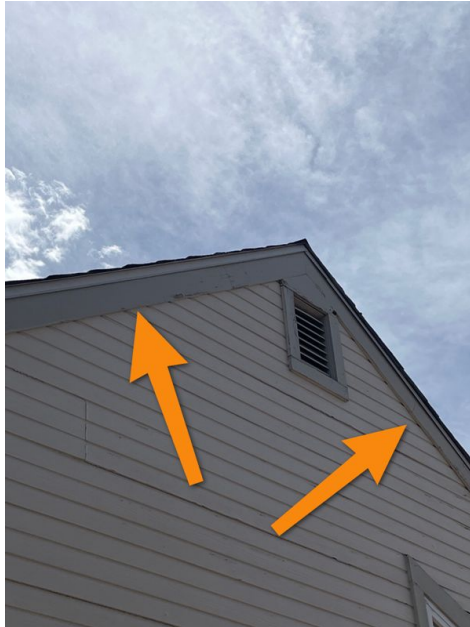
2.4.2 Soffits & Fascia

SEAL OPENINGS

Recommendation

Contact a qualified professional.

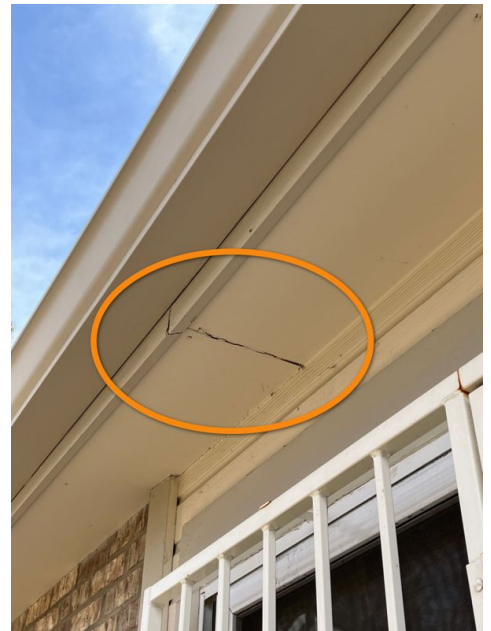
2.4.3 Soffits & Fascia

WATER DAMAGE/ROT

Recommendation

Contact a qualified general contractor.

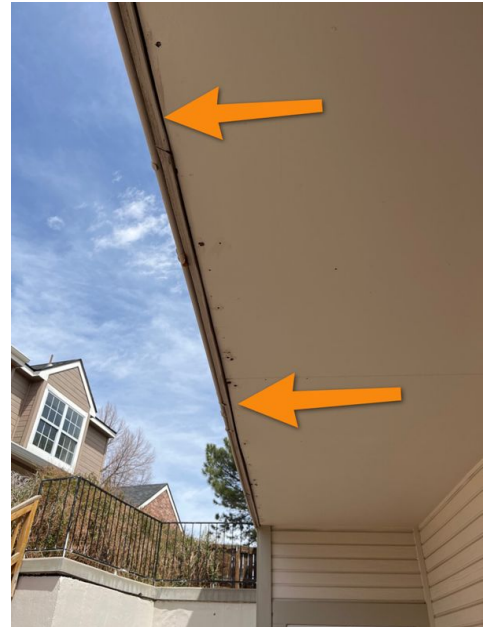
2.5.1 Exterior Covering

SEAL GAPS & PENETRATIONS

Recommendation

Contact a qualified professional.

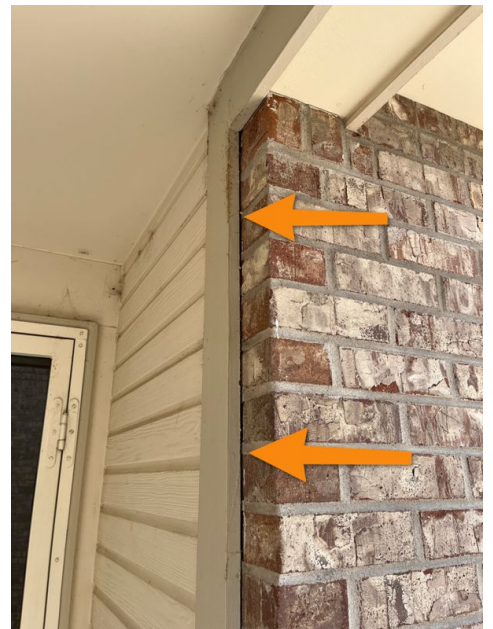
2.5.2 Exterior Covering

SIDING CLEARANCE TO CONCRETE

Recommendation

Contact a qualified siding specialist.

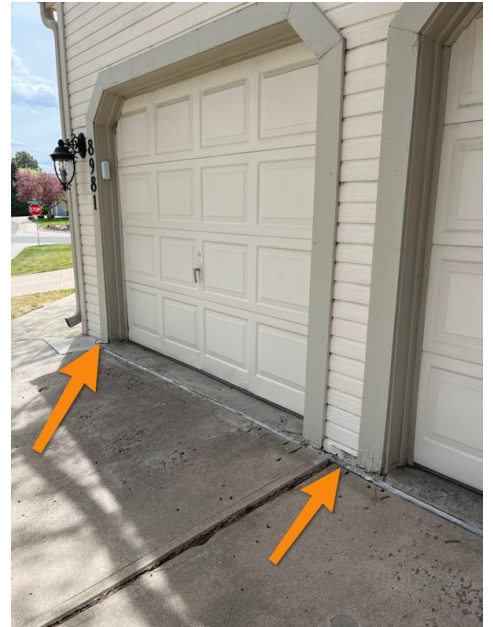
2.5.3 Exterior Covering

SIDING CLEARANCE TO GRADE

Recommendation

Contact a qualified siding specialist.

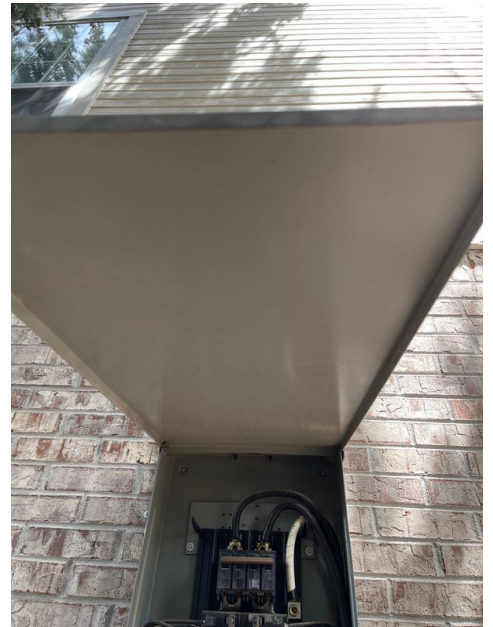
LABEL REMOVED/ILLEGIBLE

Manufacture label for the electrical panel is missing or otherwise illegible. Unable to determine panel capacity or rating.

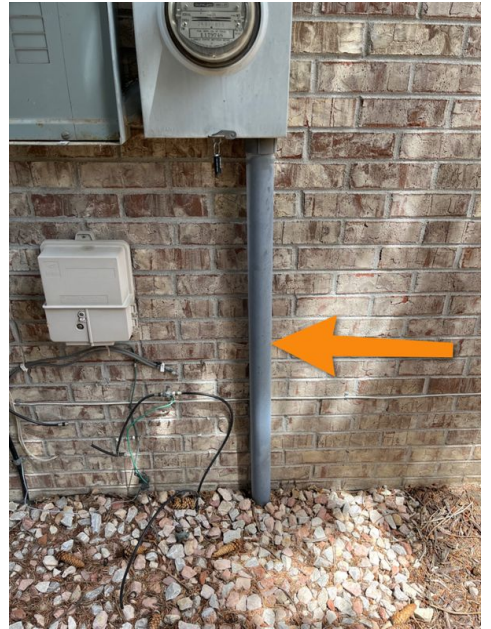
CONDUIT CLAMP(S) MISSING

Service riser conduit clamp is missing. Recommend installation of the same as may be required.

Contact a qualified electrical contractor.

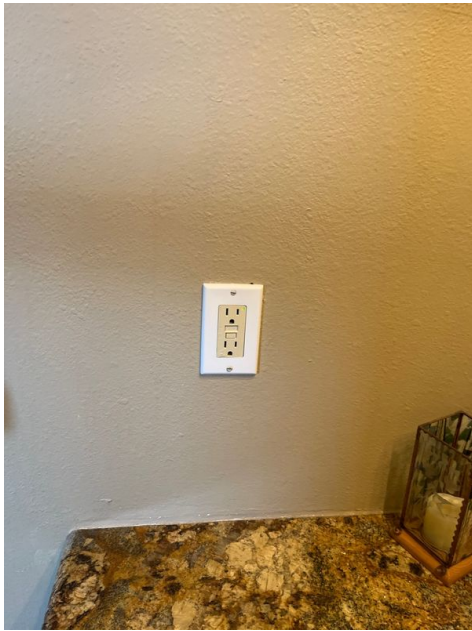
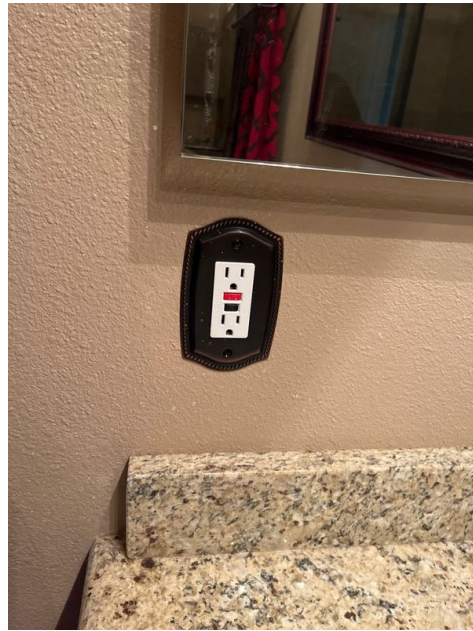
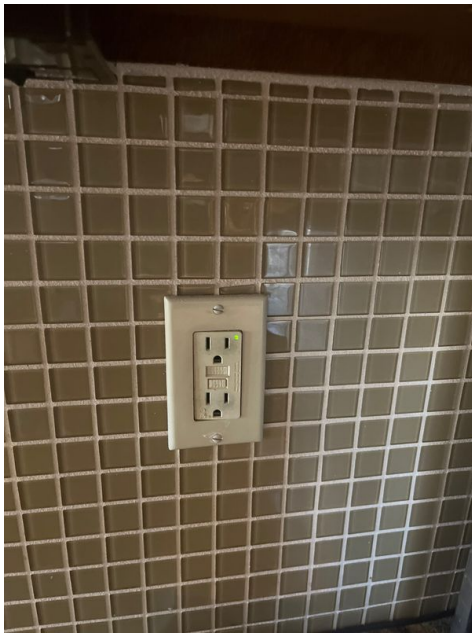
Multiple resets noted on a single circuit. This can makes resetting the GFCI difficult. Consider modification for convenience.

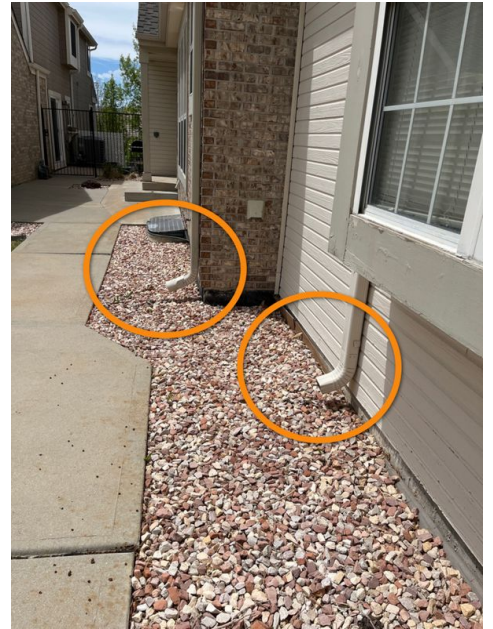
One or more downspouts drain too close to the deck structure. This can result in excessive moisture in the soil at the foundation, which can lead to foundation/structural movement. Recommend a qualified contractor adjust downspout extensions to drain at least 6 feet from the deck.

Contact a qualified gutter contractor

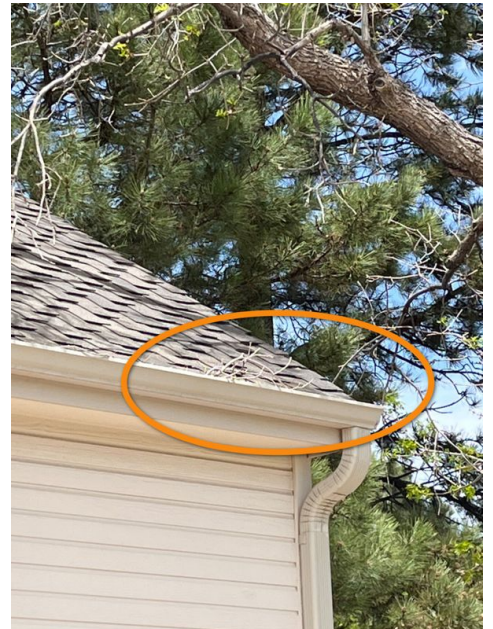
4.2.2 Roof Drainage Systems

DEBRIS

Leaves/debris noted in some of these gutter troughs. Have a contractor clean gutters as needed to facilitate water drainage towards downspouts for proper roof drainage.

Contact a qualified professional.

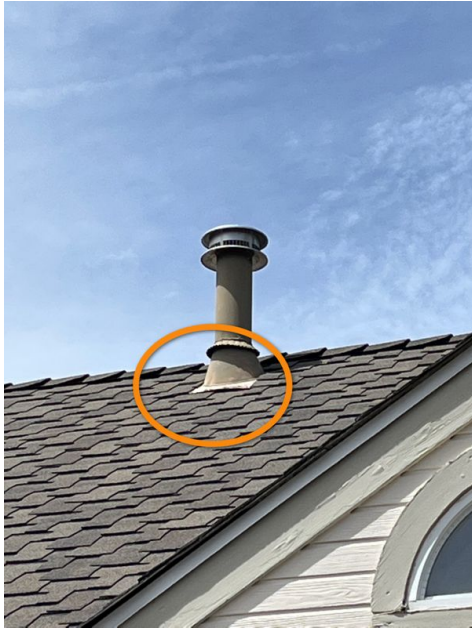
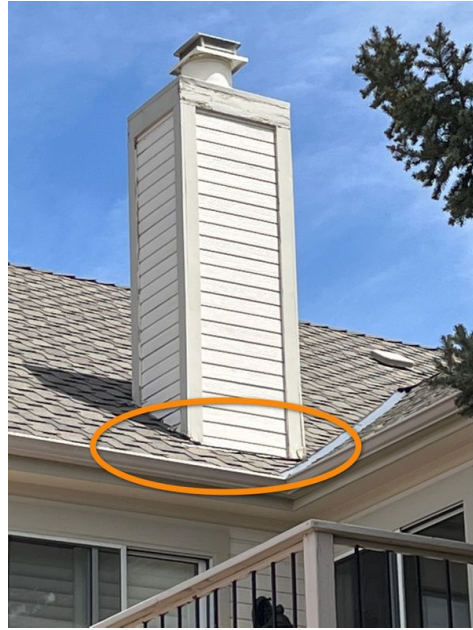
4.3.1 Flashings

LOOSE/SEPARATED

Flashings observed to be loose or separated, which can lead to water intrusion and/or mold. Recommend having a qualified licensed roofer evaluate flashing system, advise and repair or replace as necessary to prevent moisture intrusion.

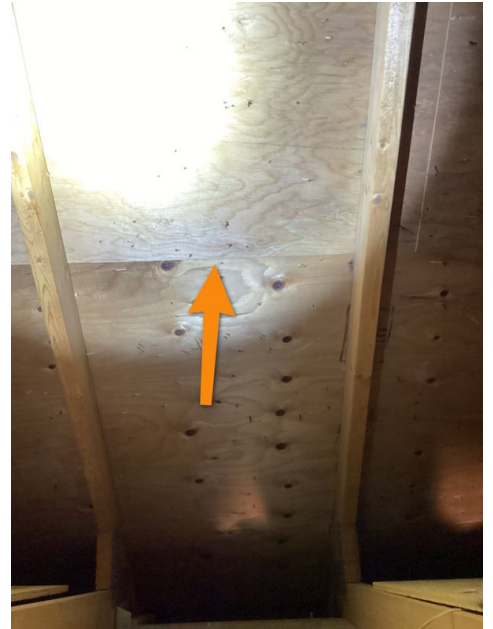
MISSING "H" CLIPS

OSB/plywood sheathing clips missing throughout this sheathing system and the panels are butted tight against each other which is not typically allowed. "H" clips are typically required by the local building department to ensure proper separation/gap between sheathing panels. Recommend having a qualified contractor inspect sheathing system, advise and correct as needed.

Contact a qualified general contractor.

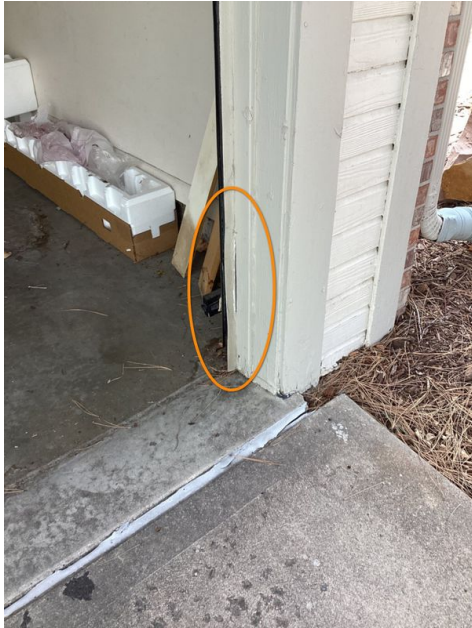
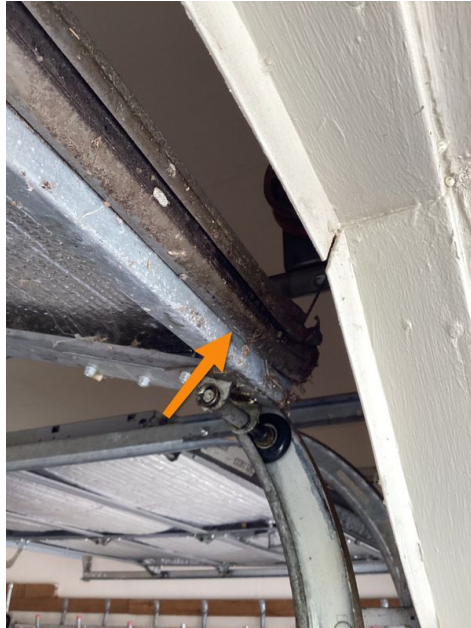
GASKET DAMAGED

Exterior garage vehicle door gasket is damaged. Recommend replace to prevent moisture intrusion.

Contact a qualified garage door contractor.

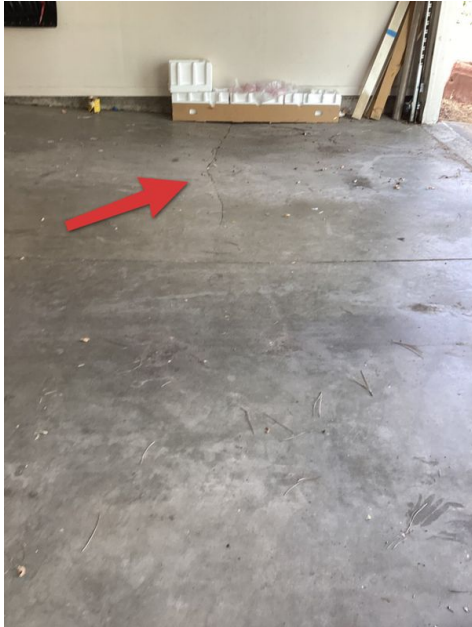
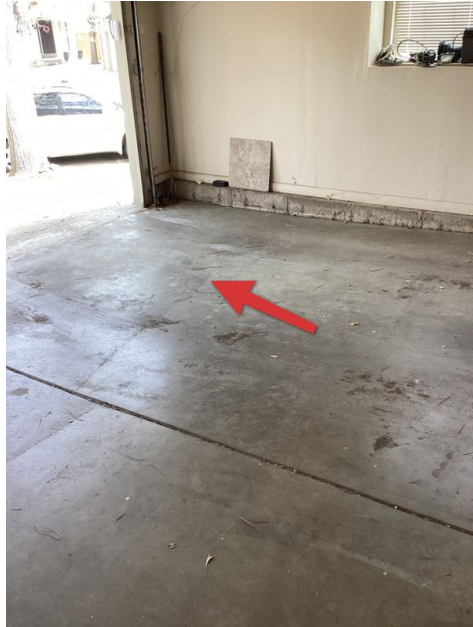
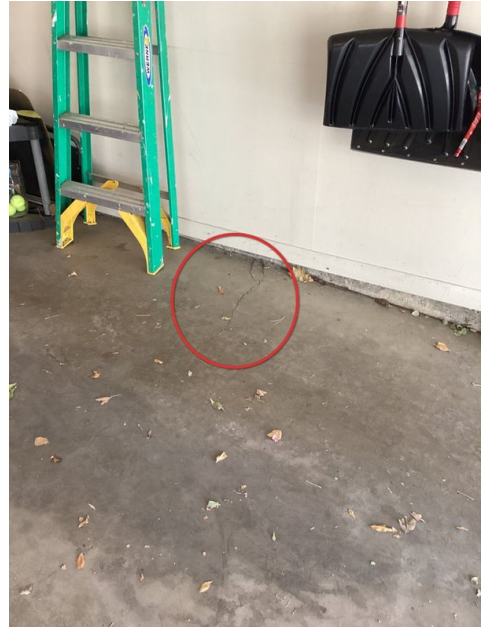
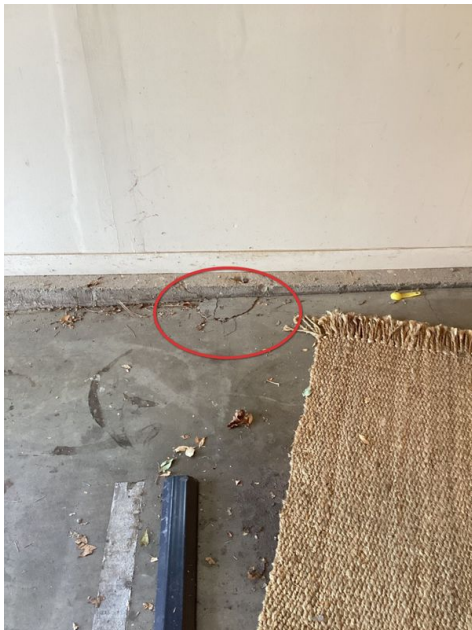
6.2.1 Floor

SIGNIFICANT CRACKING AND HEAVING

Significant cracking and heaving evident in the garage floor slab. Monitor for proper drainage away from the structure/foundation. May be advisable to replace the garage floor if condition gets worse.

Contact a qualified concrete contractor.

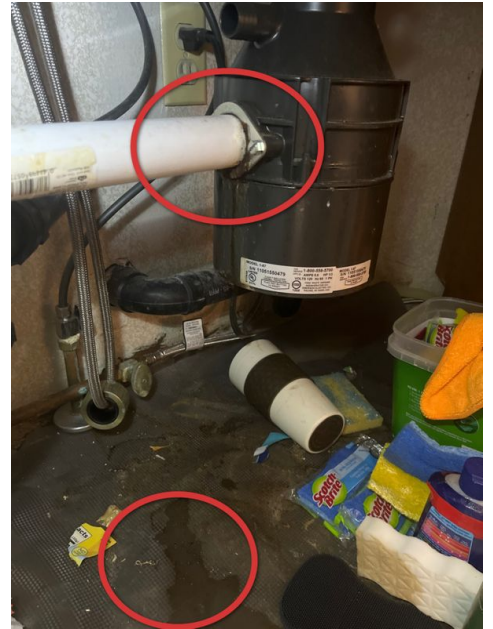
Health/Safety Hazards**ACTIVE LEAKAGE**

Active water leakage from the disposer union under the sink. Dripping into the cabinet. Recommend further evaluation and repair by a qualified contractor. Possible hidden water damage/mold.

Contact a qualified plumbing contractor.

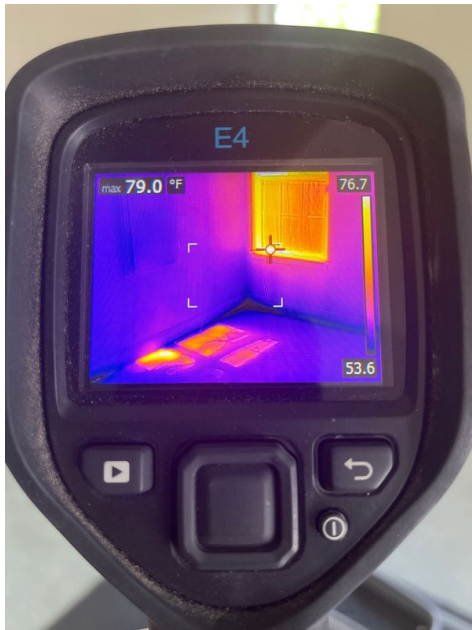
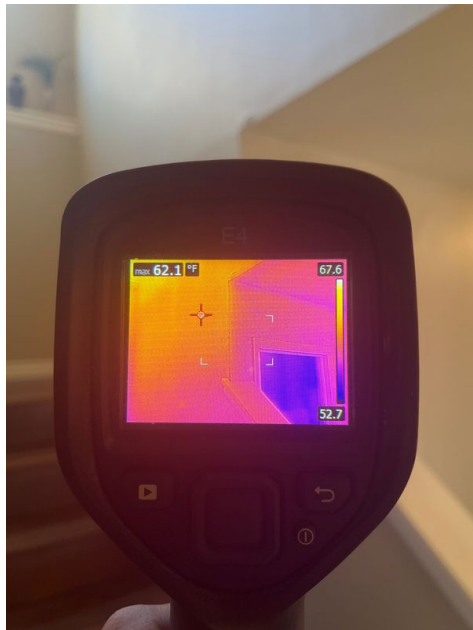
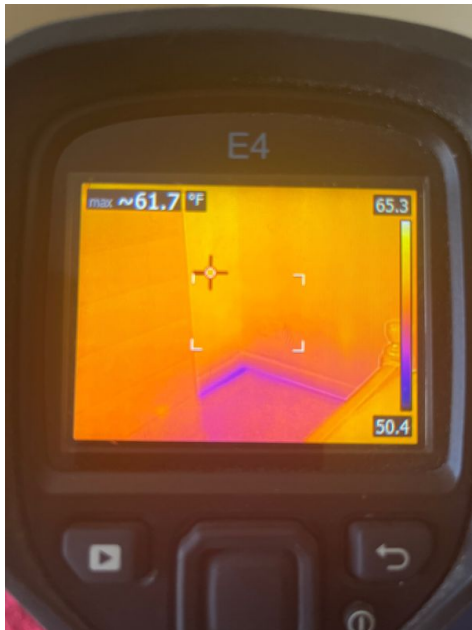
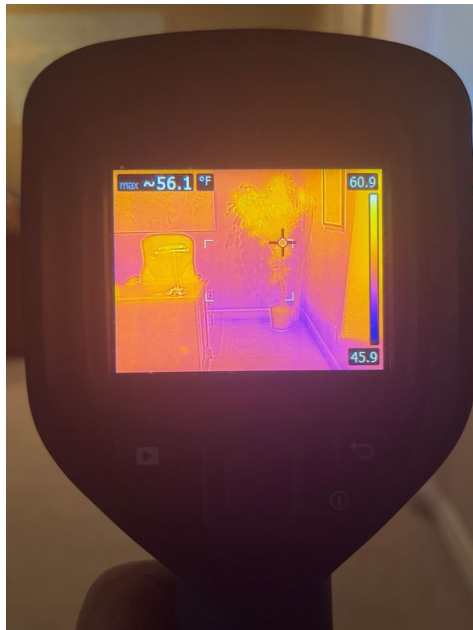
General

INFRARED SCAN NORMAL

Basement walls, ceiling and floors were scanned with an infrared camera and spot tested for moisture. Little or no moisture was detected at the time of this inspection. Monitor seasonally as a dry basement is not guaranteed.

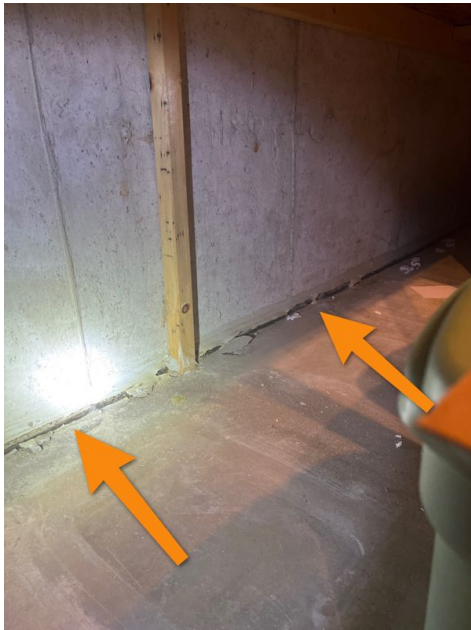
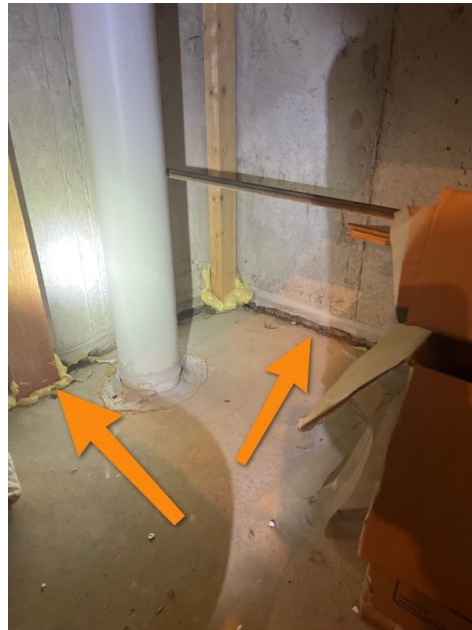
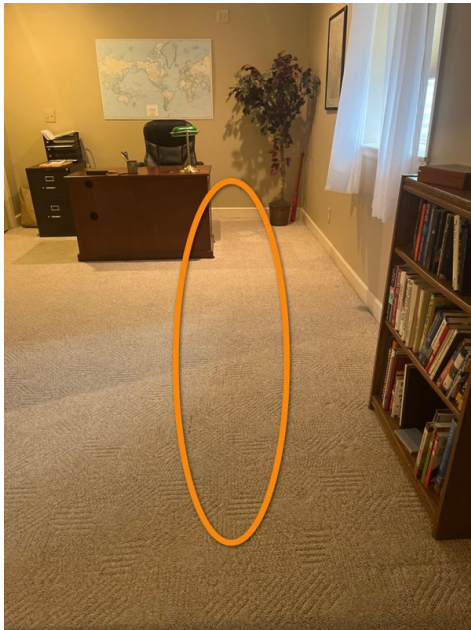
FLOOR HEAVING/SETTLING

The floor slab shows movement/settling due to soil movement. This can compromise the structural integrity of the home. Recommend a qualified structural engineer evaluate and advise on how to remedy.

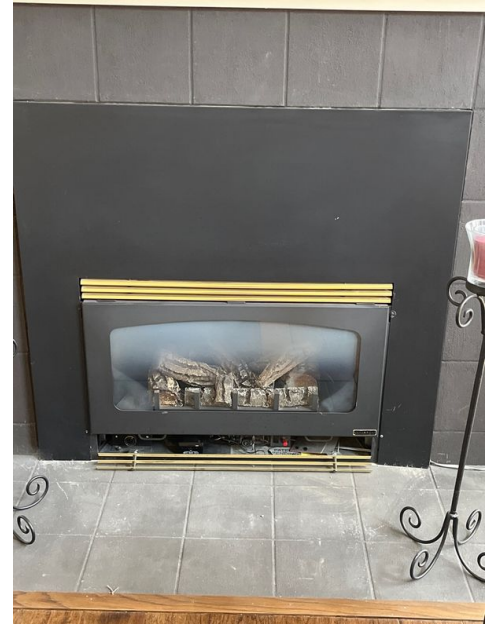
Gas fireplace failed to light in a timely manner. System is also dirty indicating neglect and lack of preventative maintenance. Recommend having a qualified specialist inspect fireplace system, service, clean, advise and correct or replace unit as necessary.

Contact a qualified fireplace contractor.

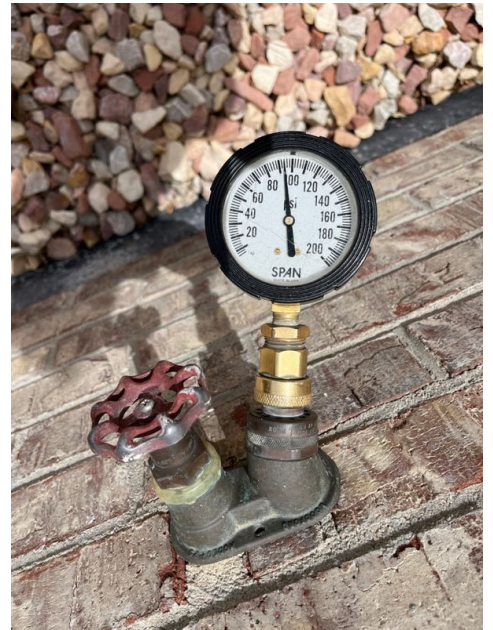
Water pressure measured high. This should typically be between 60 and 80 psi. Excessive water pressure could cause damage to plumbing fixtures and rubber hose connections. Contact a licensed plumber to inspect, adjust or install pressure reducing valve as needed.

Contact a qualified plumbing contractor.

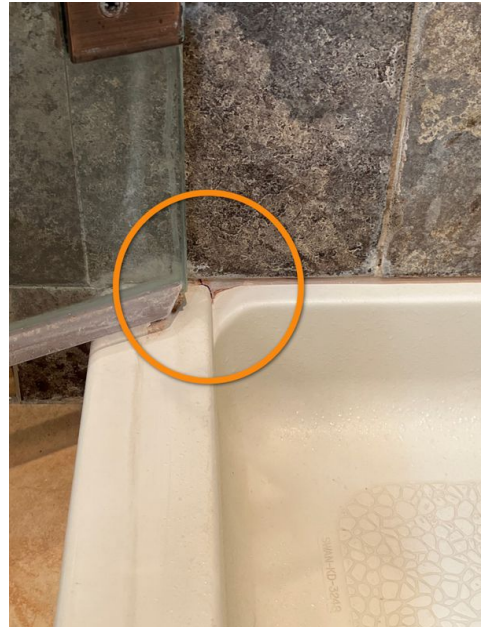
Shower pan weep holes are obstructed with caulk/grout. Recommend clean out as necessary to allow for incidental moisture drainage from behind the tilework.

Recommendation

Contact a qualified professional.

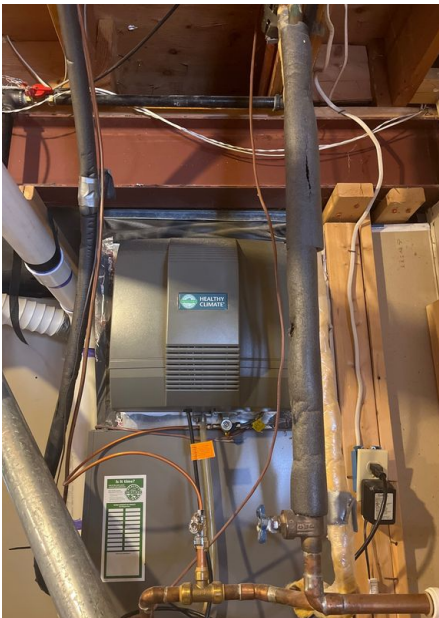
Central Humidifier: Operational

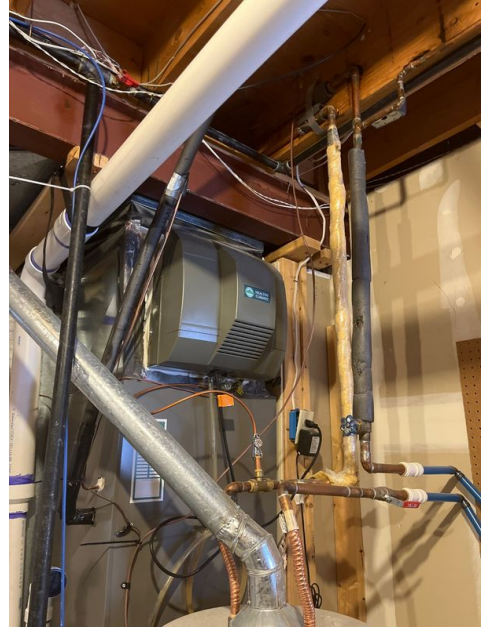
NOT ACCESSIBLE

Humidification system was neither accessible or inspected due to limited access. Recommend check with a qualified heating contractor to inspect and service humidification system before closing.

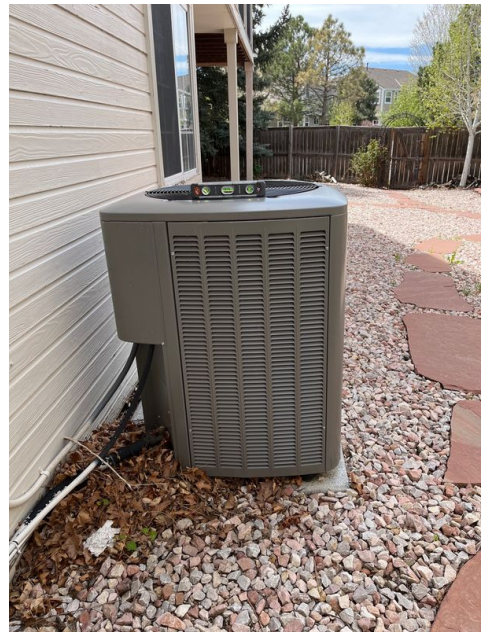
Outdoor condensing unit is out of level. Recommend further evaluation and repair by a qualified heating contractor to prevent damage to the A/C system and to promote component longevity.

Recommendation

Contact a qualified HVAC professional.

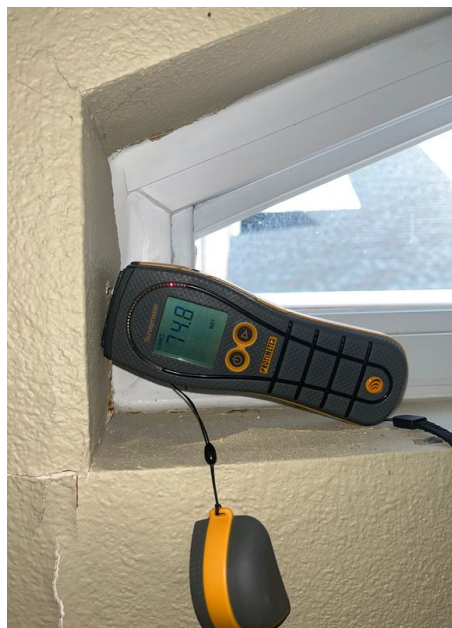
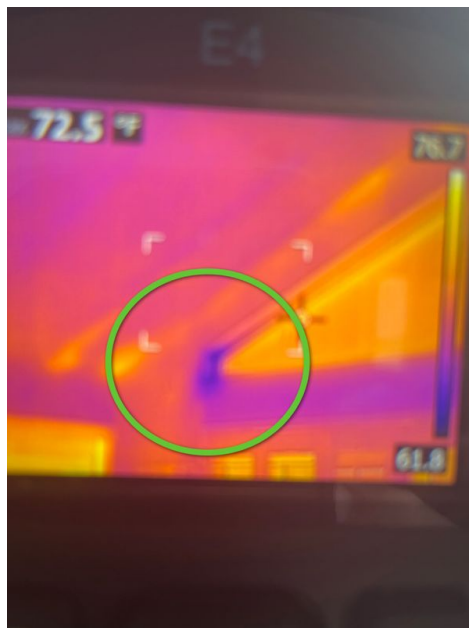
Evidence of Moisture Found

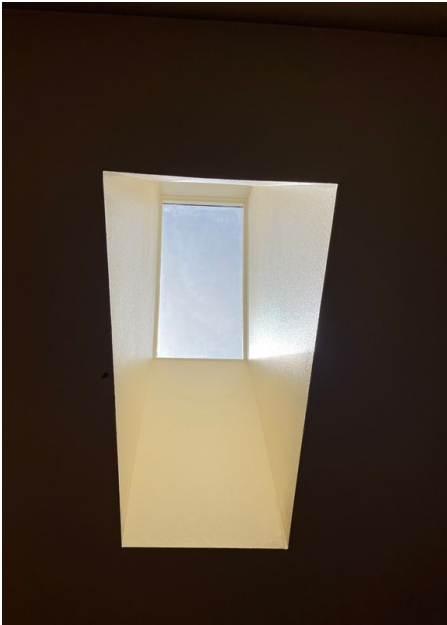
Skylights frequently do leak. Monitor regularly and have inspected seasonally for deficient flashing.

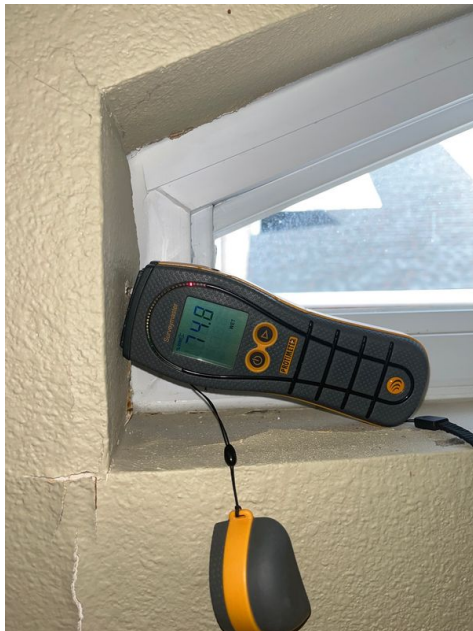
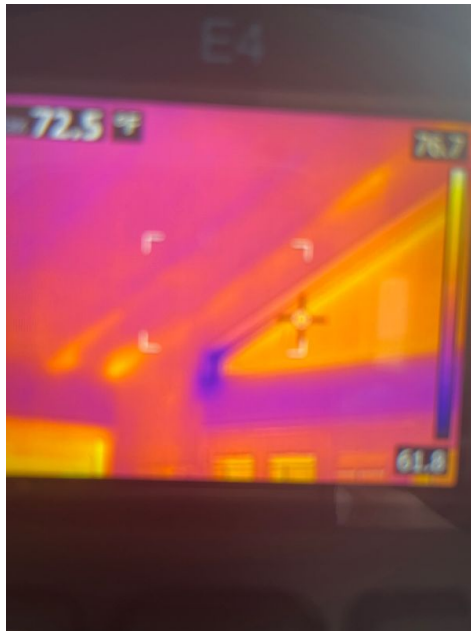
LIVING ROOM

MOISTURE DETECTED

Moisture detected in drywall with infrared and confirmed with moisture meter. Have a qualified professional investigate source of moisture and repair as needed to prevent damage and possible mold growth.

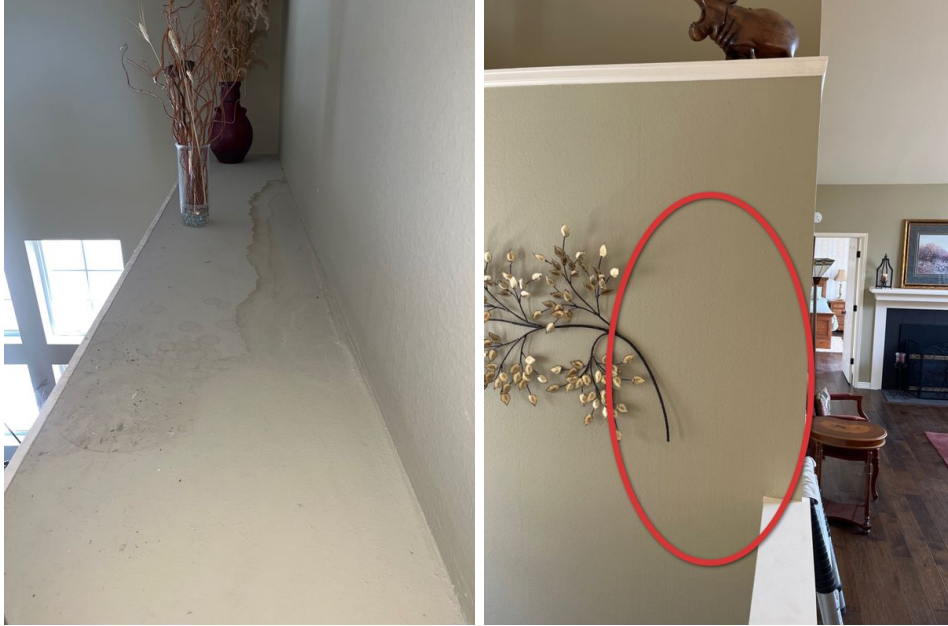
**WATER DAMAGE ON DRYWALL**

Water damage evident on drywall. Evidently due to houseplants. Recommend check with seller as to past history of leakage or licensed contractor for further evaluation. Possible hidden water damage/mold.

Recommendation

Contact a qualified general contractor.

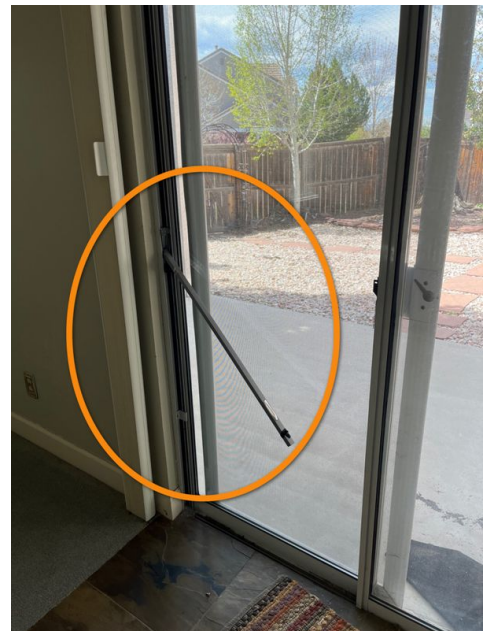
CHARLIE BAR DAMAGED

Charlie bar at rear patio sliding door damaged or otherwise inoperative. Recommend further evaluation and repair for safety and security.

Recommendation

Contact a qualified professional.

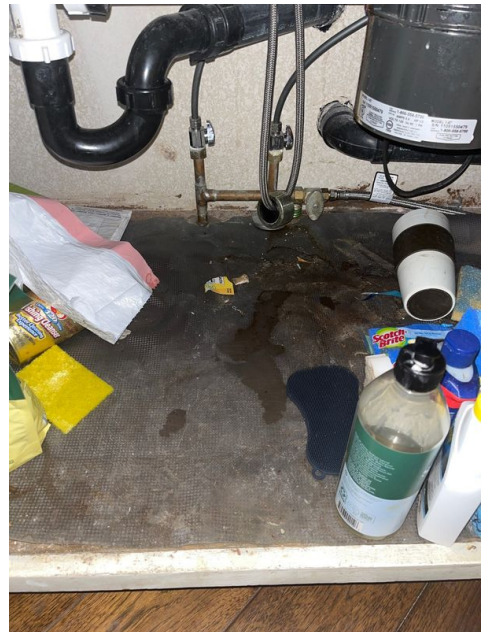
WATER DAMAGE UNDER SINK

Water damage from past leakage under the sink. Possible hidden water damage/mold. Recommend having a qualified contractor inspect cabinet system, advise and repair or replace as necessary for occupant health and safety.

Recommendation

Contact a qualified cabinet contractor.

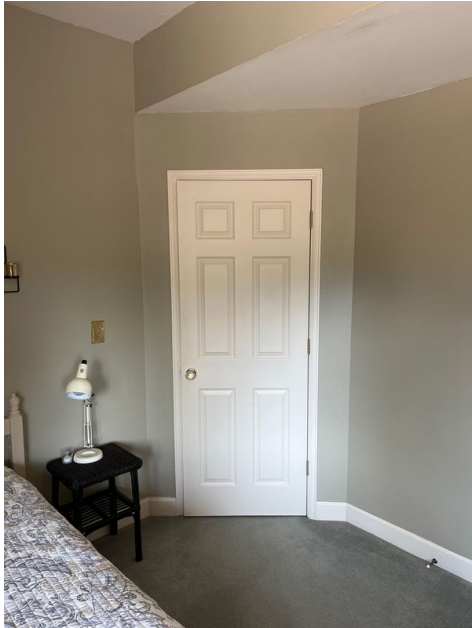
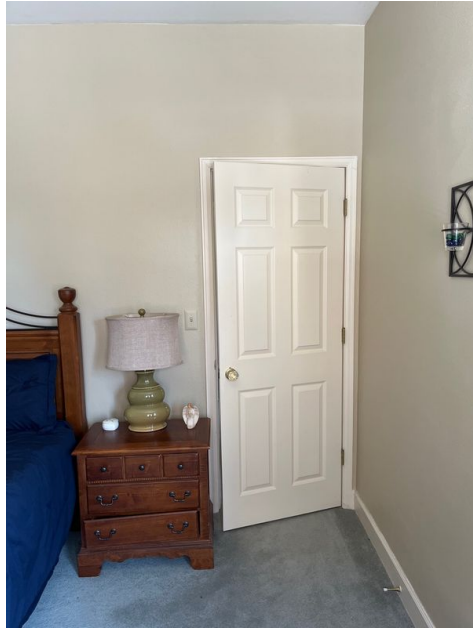
Basement Bedroom

Some interior doors bind on their frame. Recommend adjust or replace for proper function.

Recommendation

Contact a qualified door repair/installation contractor.

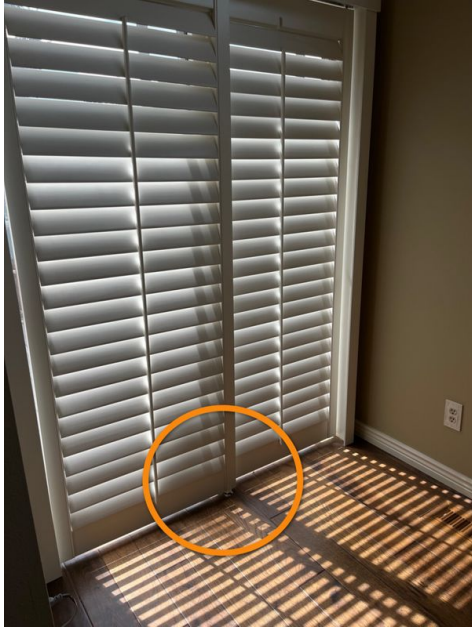
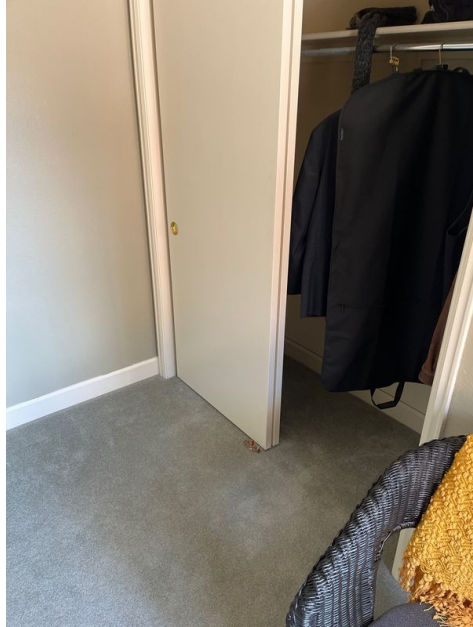
Living Room

FLOOR GUIDES DAMAGED

Floor guides damaged. Recommend repair/replace for proper function.

Recommendation

Contact a qualified professional.

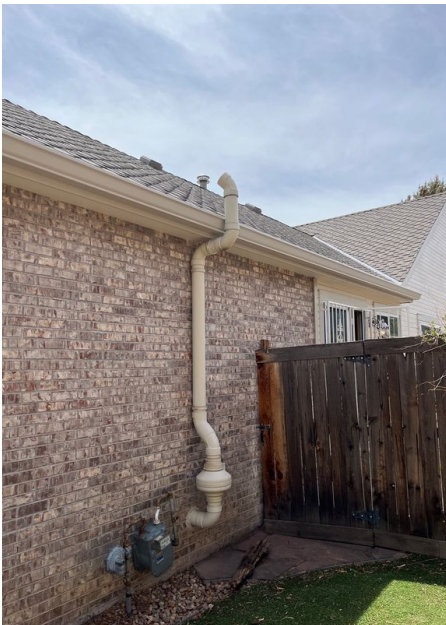
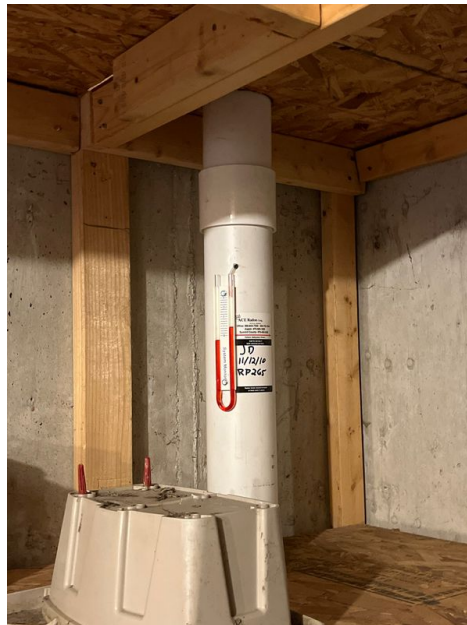
Appears Properly Installed

Cord Shorter than 6', Discharge No Less Than 10' Above Grade, Fan Located in Unconditioned Space, Fan in Working Condition, House Penetration Sealed, Local Disconnect, Manometer Present, Manometer Filled with Liquid

Radon mitigation system appears to have been properly/professionally installed. Recommend contact seller/owner for necessary documentation (warranty paperwork, receipts, etc.).
