4THRUGHT PROPERTY INSPECTIONS

RESIDENTIAL INSPECTION

1234 Main St. Lakewood CO 80226

05/08/2022 9:00AM

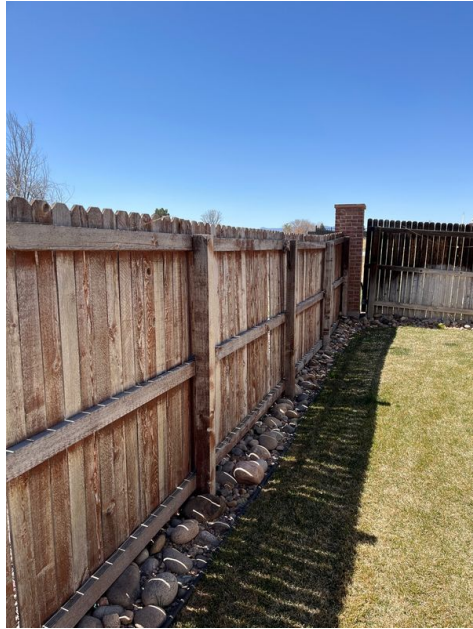
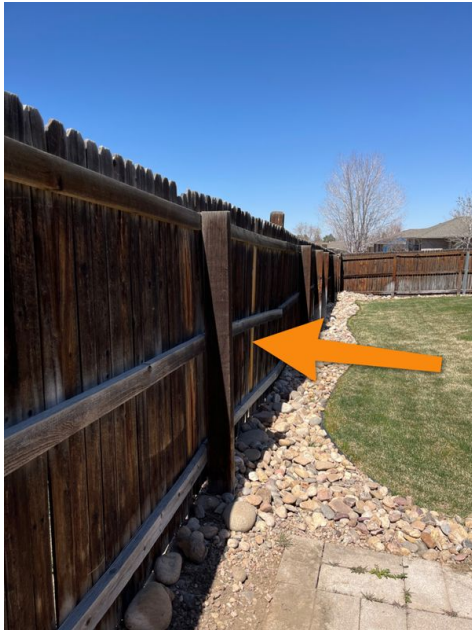
Fence is at the end of its anticipated life expectancy. Some areas are damaged and/or leaning. Recommend having a qualified contractor inspect fence system, advise and repair or replace as necessary for proper function and improved longevity.

Contact a qualified fencing contractor

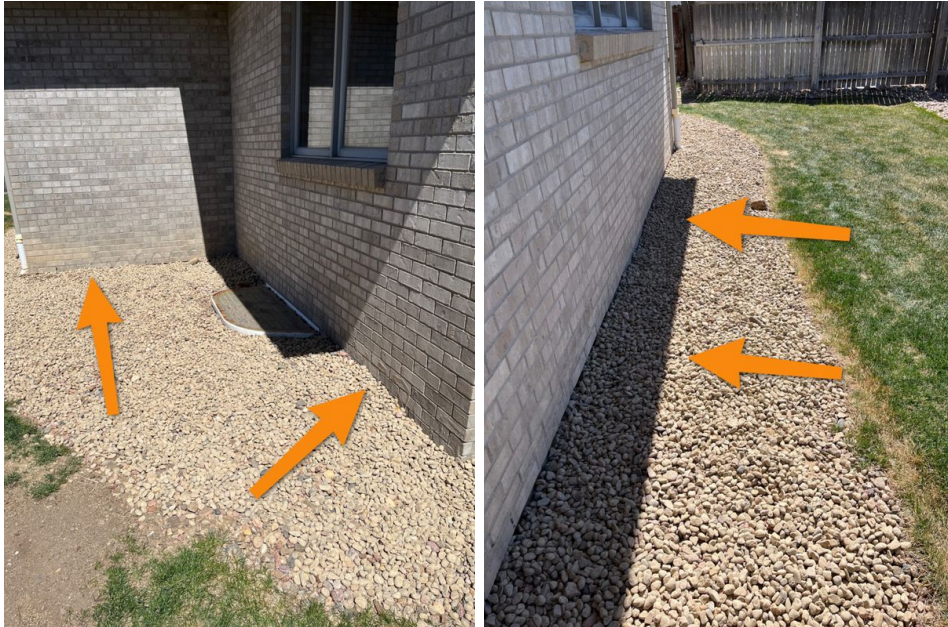
2.1.2 Grading & Landscaping

Monitor drainage around structure, landscape is level to negative in areas, potential for water entry to foundation and structure. Regrade as needed to move water away.

Contact a qualified grading contractor.

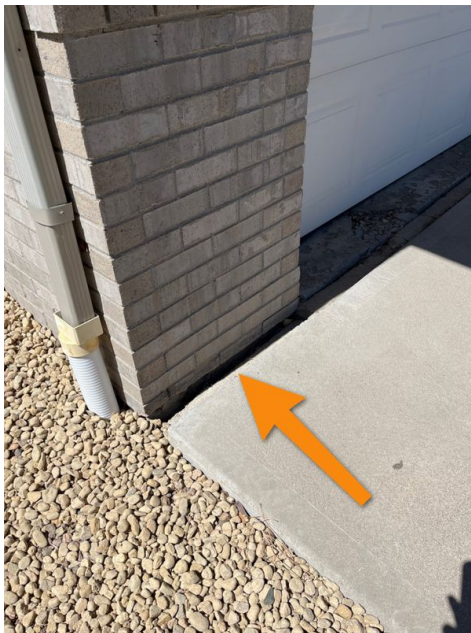
2.2.1 Driveways & Walkways

DRIVEWAY DETERIORATION

Notable deterioration, settlement, spalling and cracking noted in driveway/ garage concrete. Seal cracks and / or patch to prevent further movement and water intrusion. Recommend having a qualified contractor inspect concrete flatwork system, advise and correct or replace as necessary.

Contact a qualified concrete contractor.

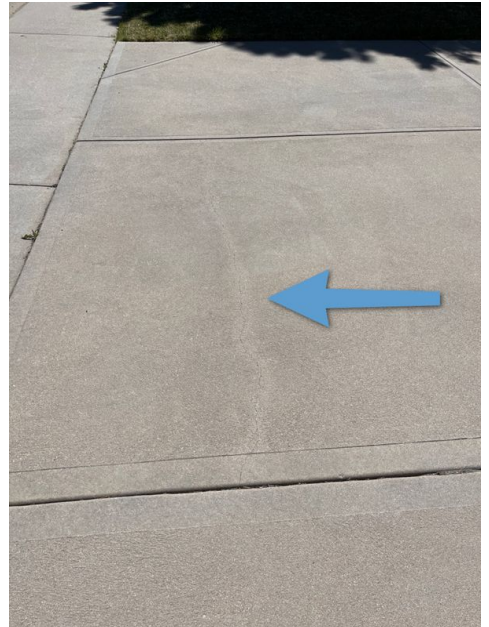
2.2.2 Driveways & Walkways

NORMAL WEAR AND TEAR

Typical cracks, spalling and age-related deterioration noted in walkway and driveway. A sealer is recommended in the cracks to help prolong its useful life expectancy and reduce further movement/settlement.

Contact a qualified concrete contractor.

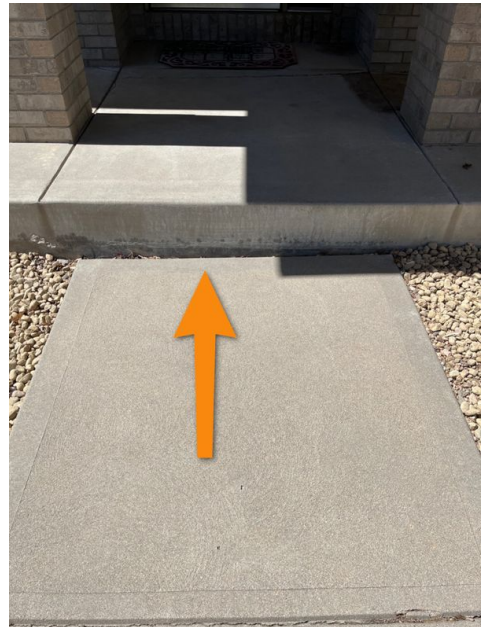
2.2.3 Driveways & Walkways

Front walkway/stairway has settled. Monitor and divert water away to prevent further settlement. Future repairs may be necessary if settlement continues.

Contact a qualified concrete contractor.

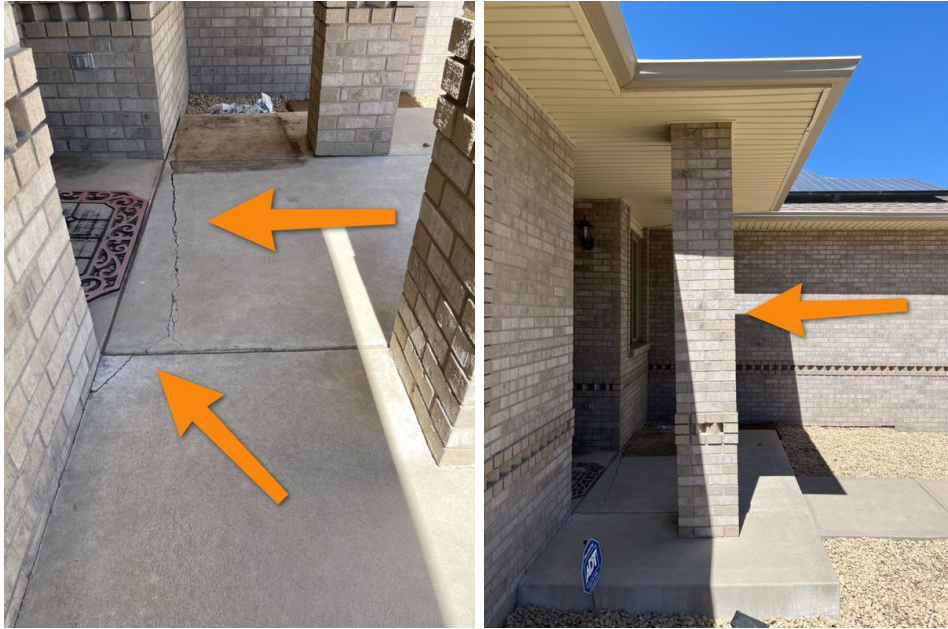
2.3.1 Porches, Decks, & Patios

Significant settlement evident at the front porch system. Large cracking and column movement noted as well. Recommend having a qualified contractor inspect concrete flatwork system, advise and repair or replace as necessary for proper function and improved longevity.

Contact a qualified general contractor.

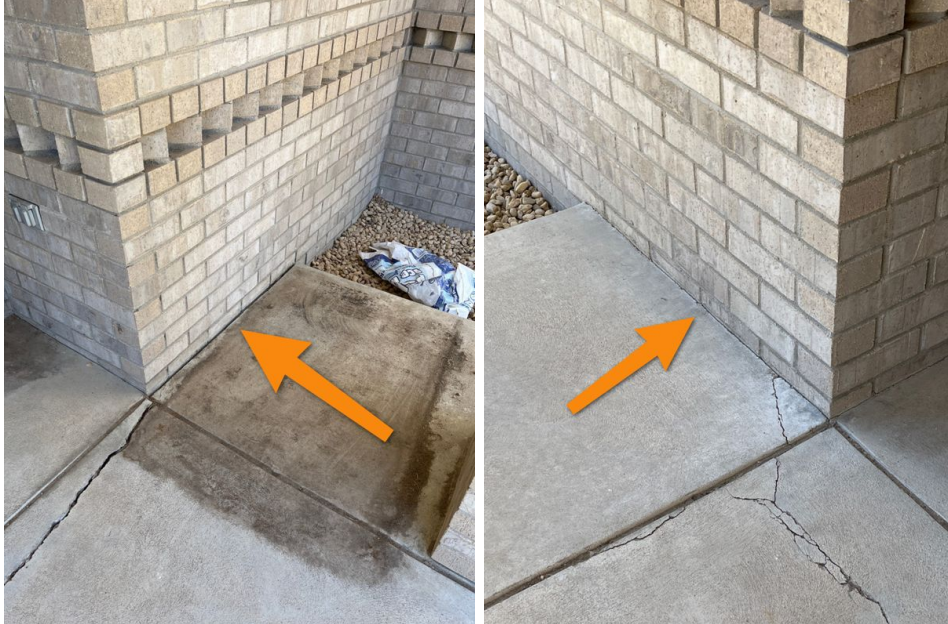
2.3.2 Porches, Decks, & Patios

Recommend seal any gaps or penetrations at concrete junctions to prevent moisture intrusion and subsequent damage or settlement.

Contact a qualified professional.

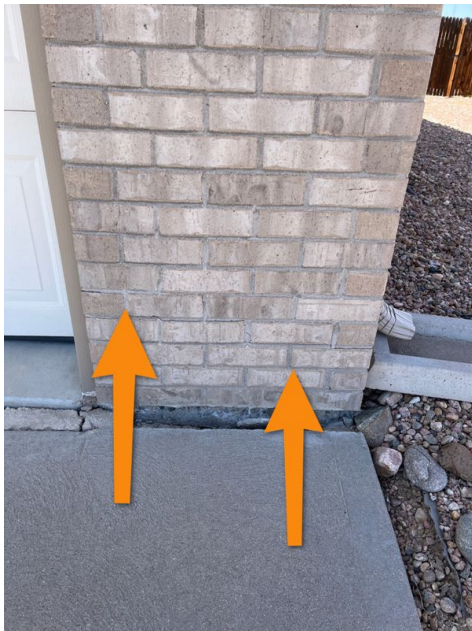
Garage East

TYPICAL STAIRSTEP CRACKING

Typical stairstep cracking noted in brickwork, associated with normal settlement. Have a mason repair/repoint as needed to prevent moisture entry and further damage.

Contact a qualified masonry professional.

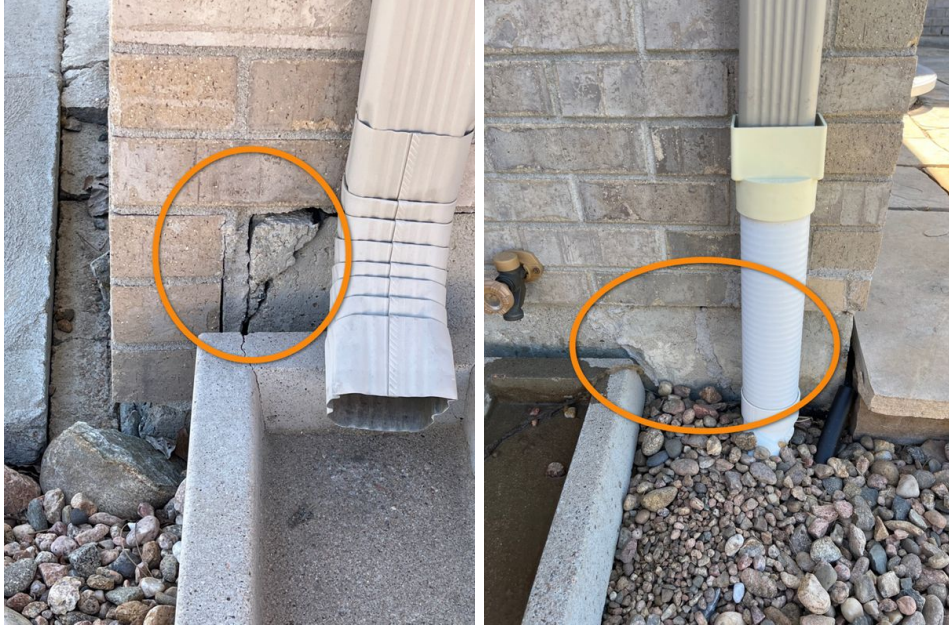
2.6.1 Exterior Foundation Wall

CORNER CRACKS

Some cracks noted at the corners of foundation wall. This is typical of a brick home. Have a contractor patch cracks as needed to secure and help prevent moisture entry.

Contact a qualified professional.

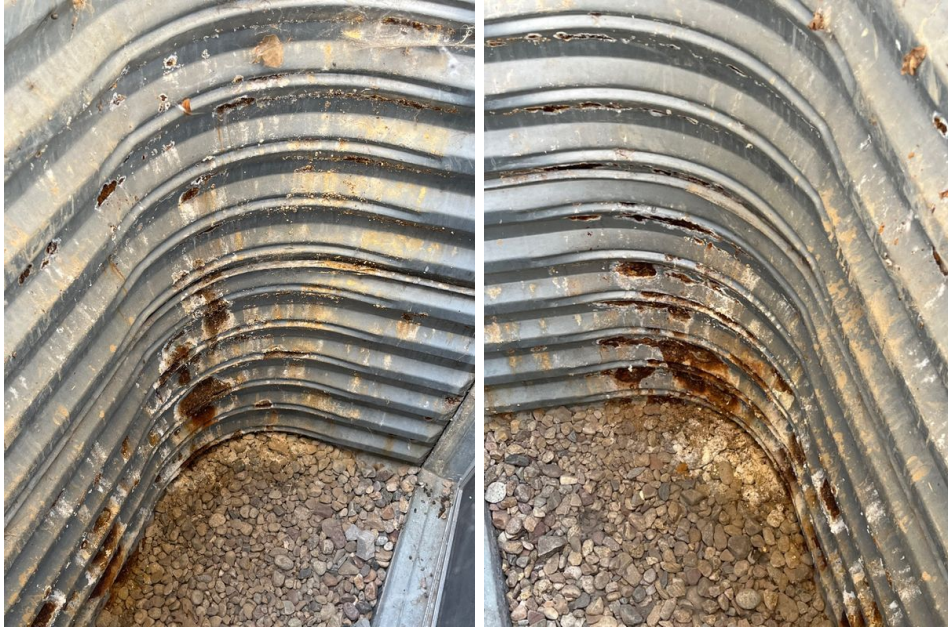
2.9.1 Window Wells

SIGNIFICANT RUST

Significant rust/deterioration noted on window well(s). Recommend having a qualified contractor inspect window well system, advise and replace as necessary for proper function.

Contact a qualified general contractor.

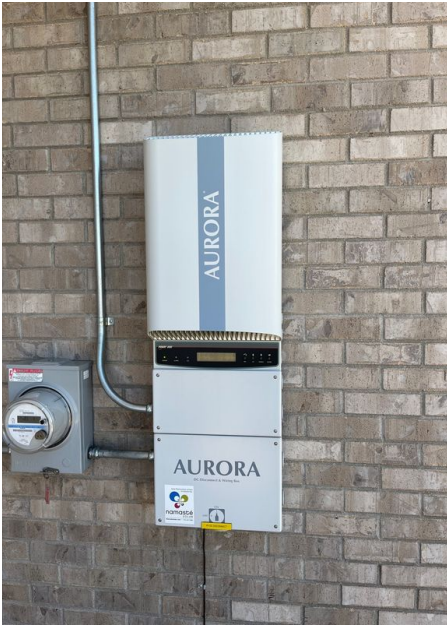
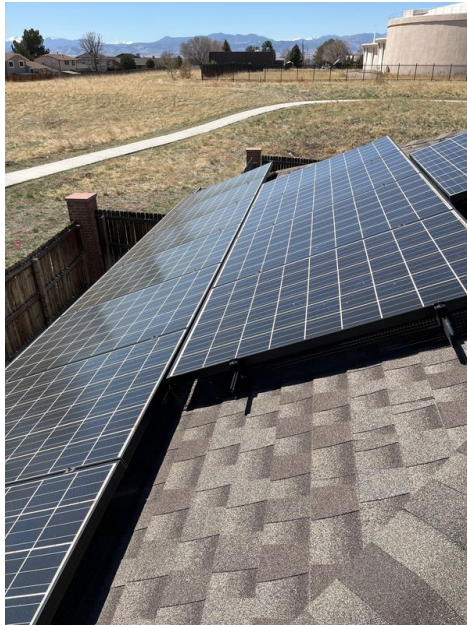
Main Distribution Panel: Solar System Present

Photovoltaic solar system present. Inspection and testing of the PV solar system is beyond the scope of this or any home inspection. Client is strongly encouraged to consult the homeowner and solar system provider for additional information, past operation, permitting issues and/or outstanding issues with regards to this system.

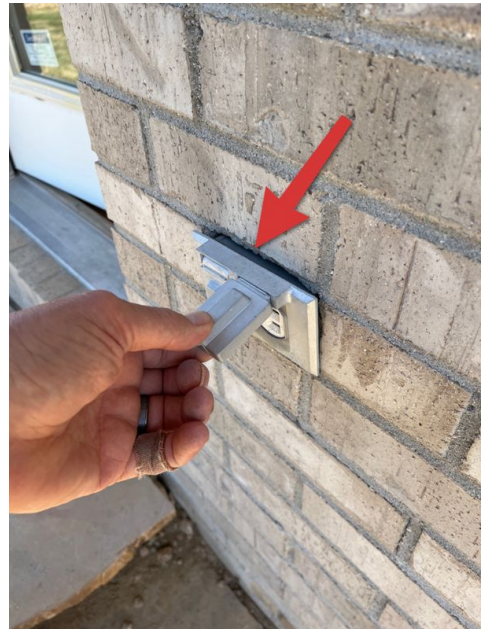
3.4.1 Branch Circuit Wiring/Receptacles

RECEPTACLE(S) LOOSE

Receptacle is very loose. Recommend further evaluation and repair by a licensed electrician for safety.

Contact a qualified electrical contractor.

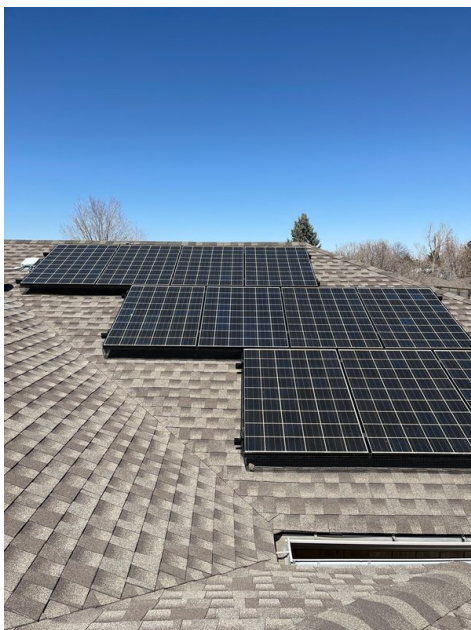
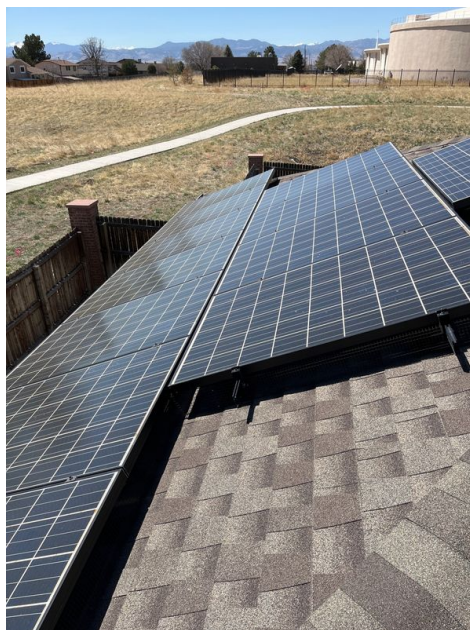
SOLAR PANELS

Roof system partially concealed with solar panels. Unable to inspect thoroughly.

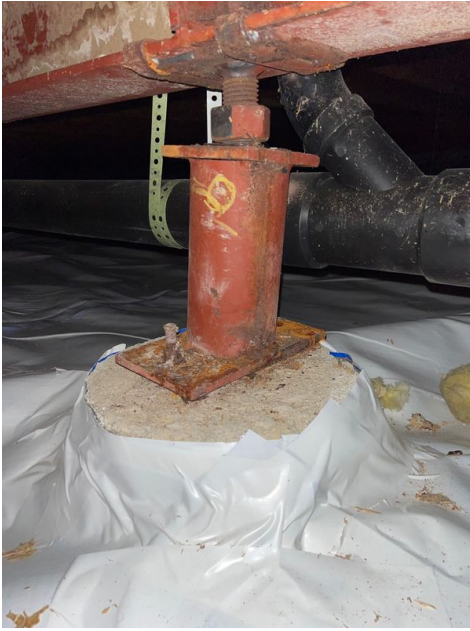
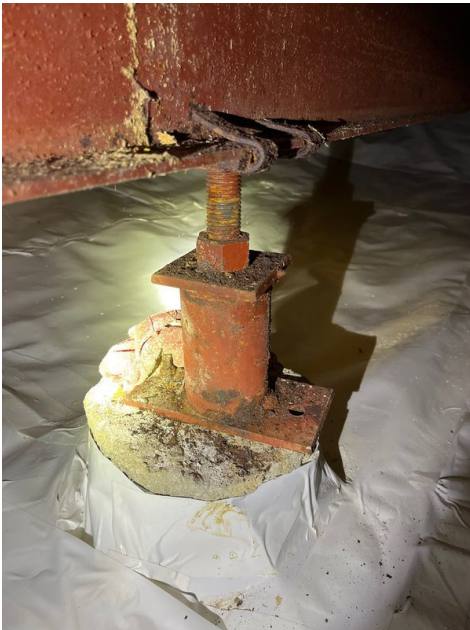
8.5.1 Posts

CORRODED POSTS

Evidence of rust/corrosion at the bottom of metal post. Post plates appear to be inadequately secured and concrete piers deteriorating as well. Have a contractor treat/repair as needed to prevent further deterioration or possible failure.

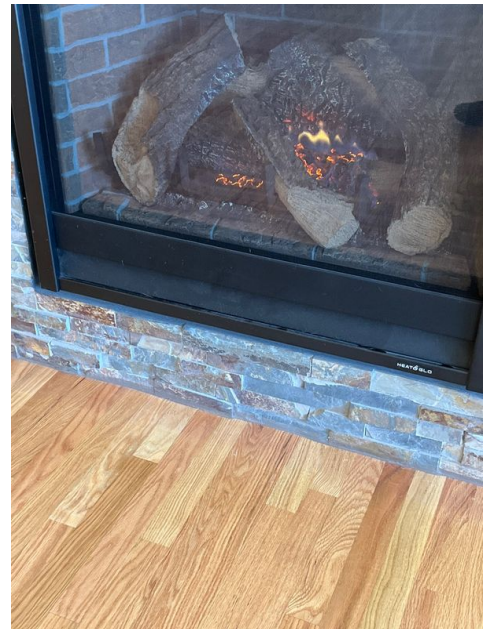
CONTROLS CONCEALED

Gas fireplace controls are largely concealed and were not accessible without dismantling the unit. System was functionally checked only.

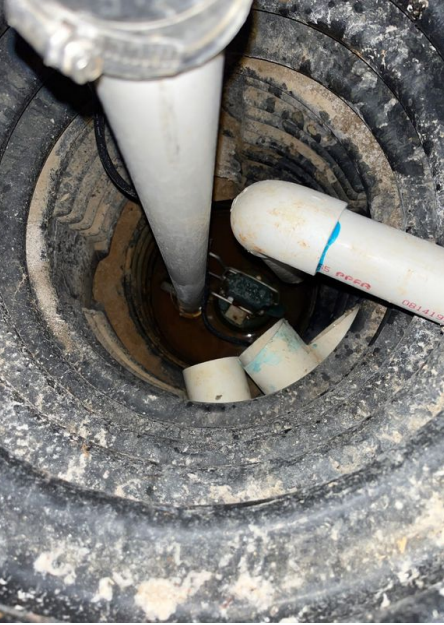
Sump Pumps : Standing Water, Pump Tested

About 4 inches of standing water in the sump pit at the time of this inspection. Sump pump was manually actuated by lifting the float assembly. System energized and discharged water as expected. Monitor pump for future operation.

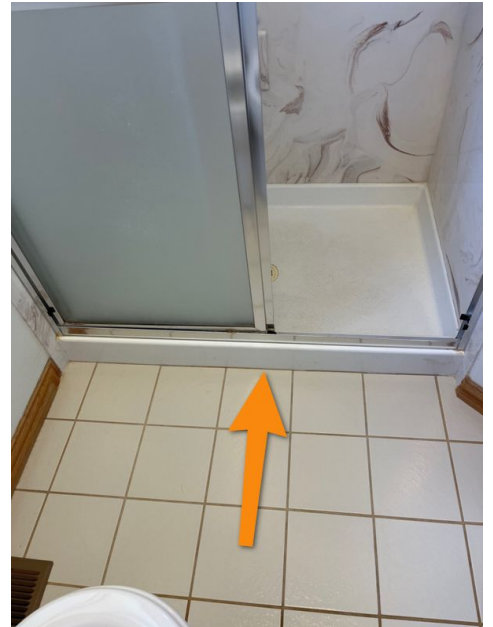
Caulk at base of tile and in corners to reduce potential for moisture entry/damage. Visible gaps in caulk throughout.

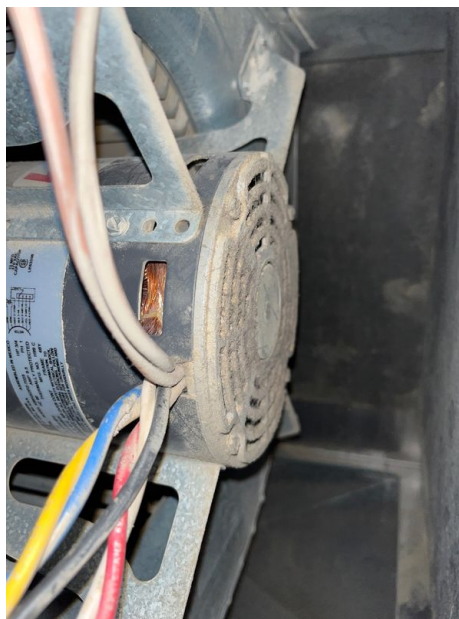
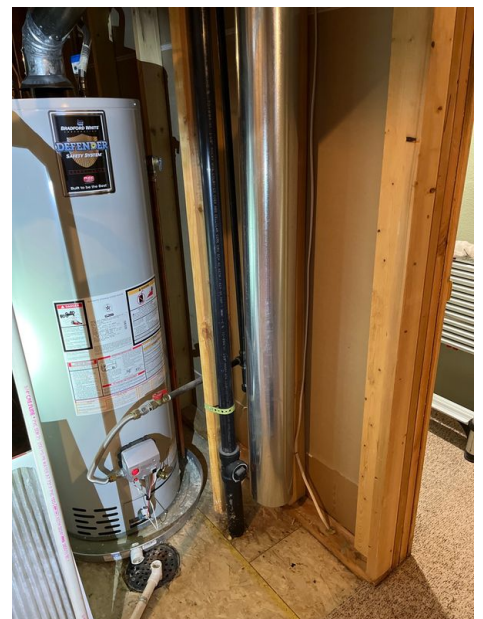
Furnace: Blower & Motor
Operational, Dirty

Furnace: Combustion Air Supply
External

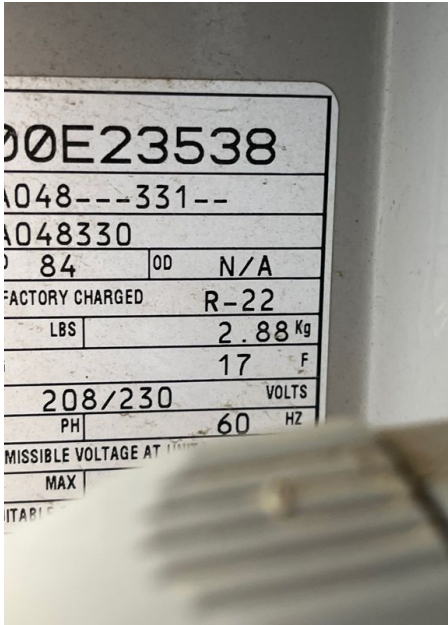
Air Conditioning: R-22 Freon

A/C system contains R-22 Freon; this product is being phased out. Expect shortened life of condenser as system becomes obsolete.

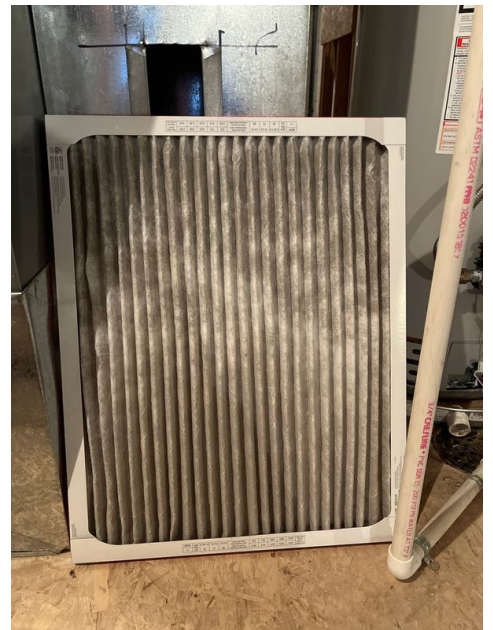
HVAC system filter is dirty. Recommend clean or replace filter for best function and efficiency.

Recommended DIY Project

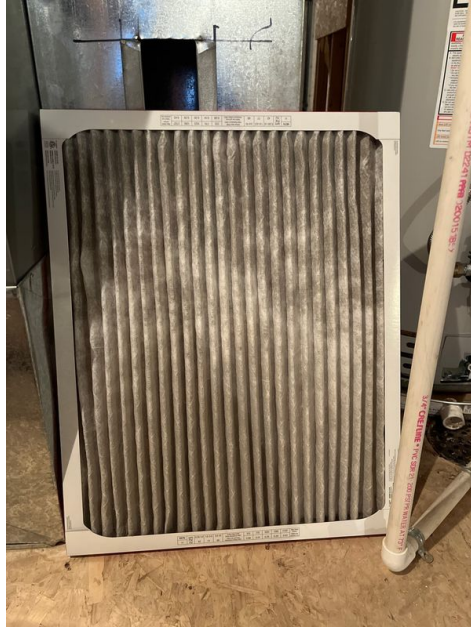
11.2.2 Furnace

Furnace was operational at inspection. 0 ppm CO detected in air supply throughout the house. Heating system is dirty indicating a lack of preventative maintenance. System is also nearing the end of its reasonable life expectancy. Recommend having a qualified licensed heating contractor inspect HVAC system, clean/service, advise, and correct as necessary for proper function and improved longevity. Budget accordingly to replace this furnace.

Contact a qualified HVAC professional.

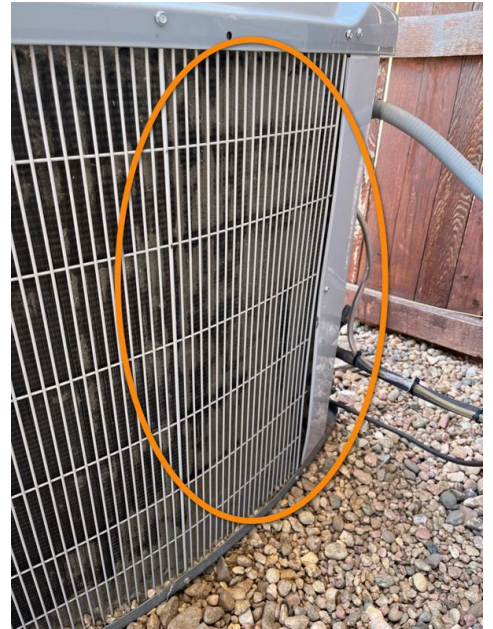
11.4.1 Air Conditioning

Exterior condensing unit dirty. Have an HVAC professional clean system to help prevent compressor damage and promote proper function.

Contact a qualified HVAC professional.

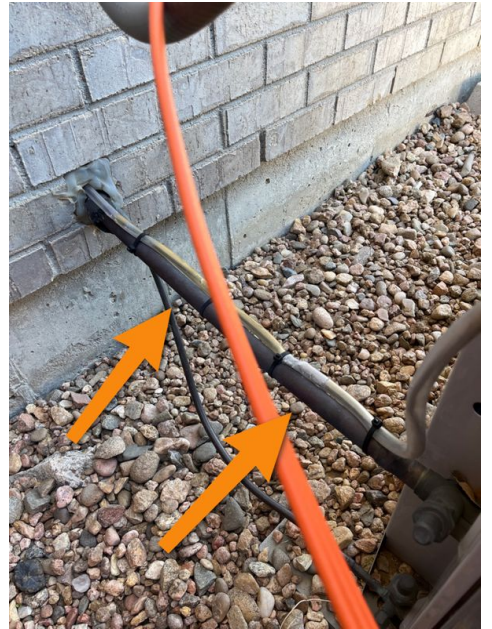
11.4.3 Air Conditioning

Insufficient insulation noted on refrigerant line. Replace damaged/inadequate insulation on the A/C refrigerant lines as necessary to promote proper function.

Contact a qualified HVAC professional.

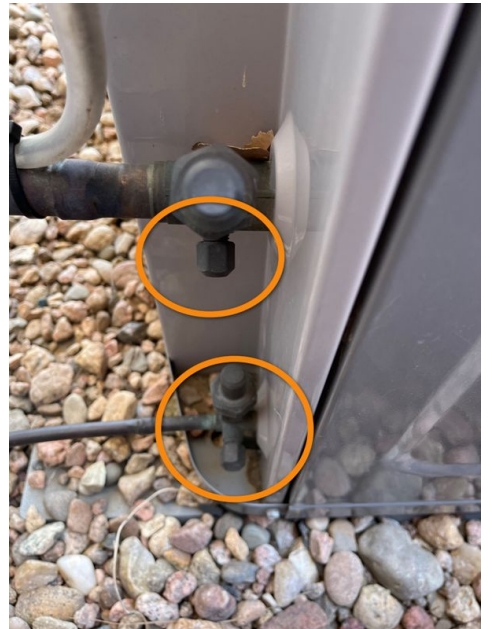
11.4.4 Air Conditioning

MISSING LOCKS

Exterior A/C condenser refrigerant locks are missing. Recommend installation the same as has been required for the last few years to deter refrigerant theft.

Contact a qualified HVAC professional.

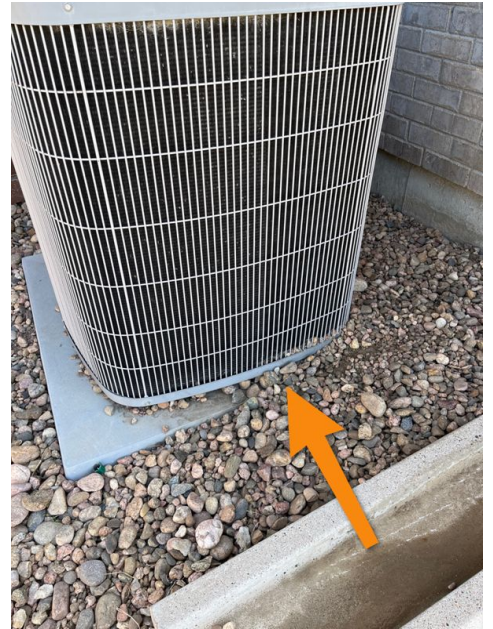
11.4.5 Air Conditioning

RAISED PAD CONCEALED

Raised support pad for the A/C condenser is partially concealed. Recommend rework landscaping to establish proper 3 inch clearance above grade.

Contact a qualified professional.

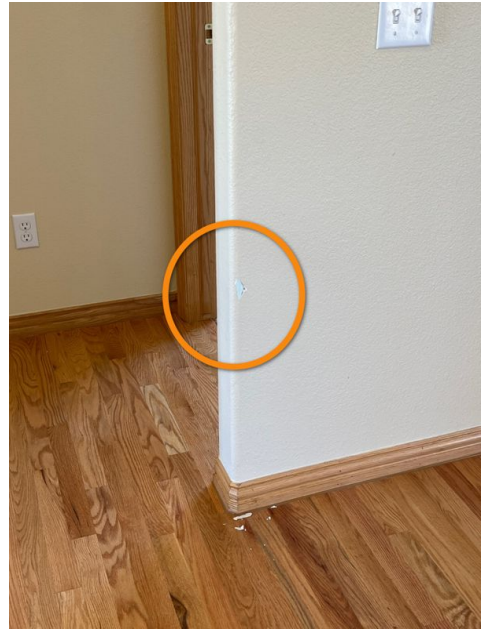
DRYWALL DAMAGE

Drywall damage evident. Recommend repair as desired.

Contact a qualified drywall contractor.

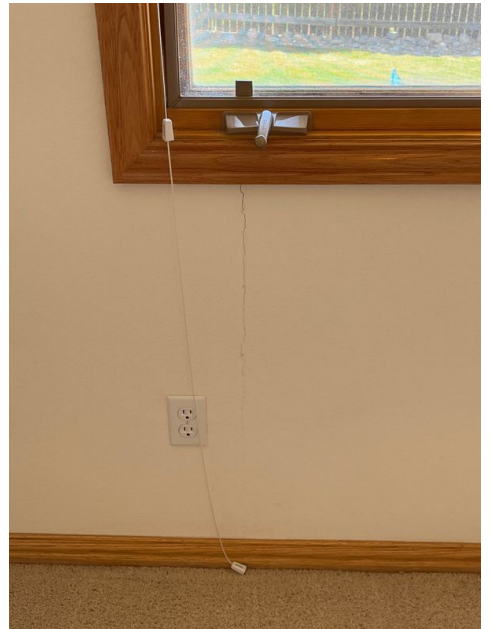
12.3.2 Walls

SEAM CRACKS

Vertical seam settlement/shrinkage crack(s) noted in drywall. This is typical. Monitor for further movement. Repair cosmetic damage as desired.

Contact a qualified drywall contractor.

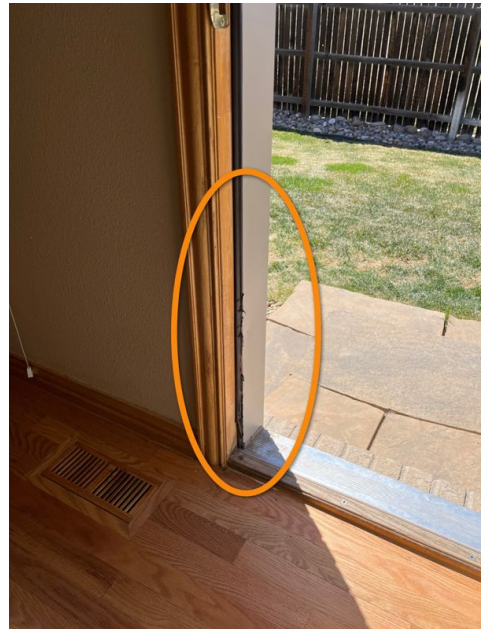
WEATHERSTRIPPING DAMAGED

Weatherstripping is damaged at the exterior door. Recommend replace damaged weatherstripping as necessary to prevent moisture intrusion and to promote energy efficiency.

Contact a handyman or DIY project

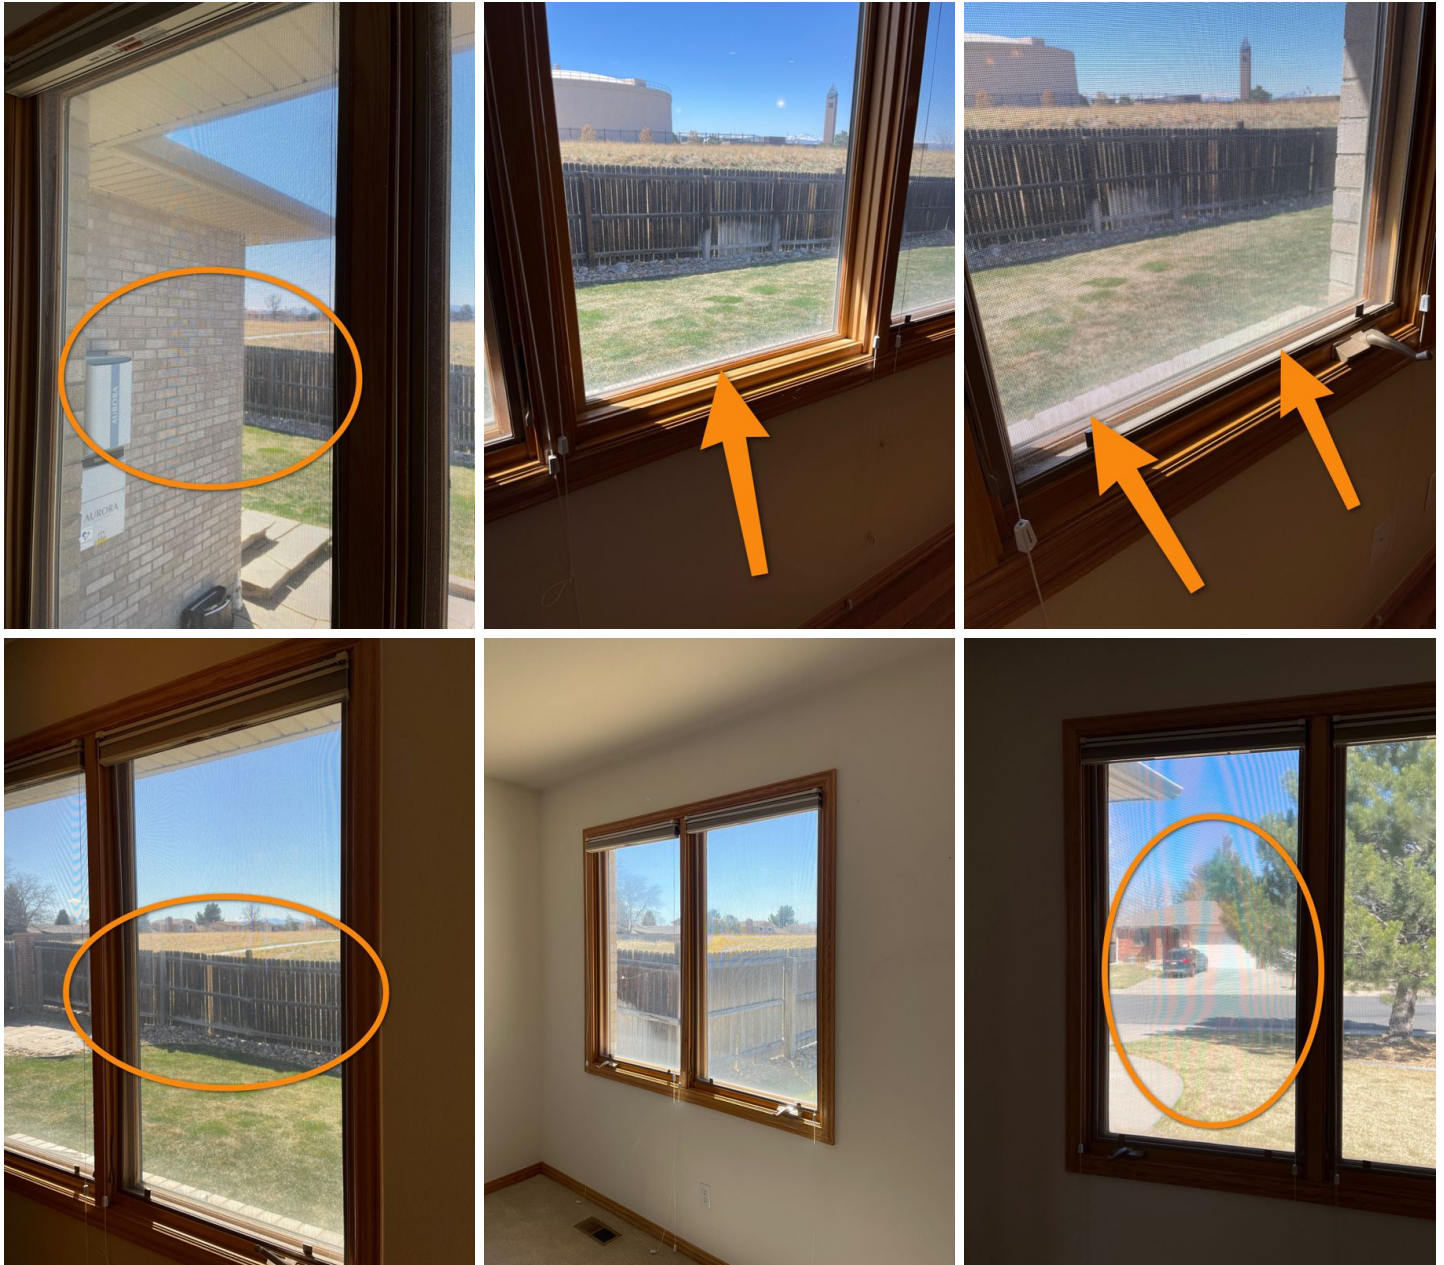
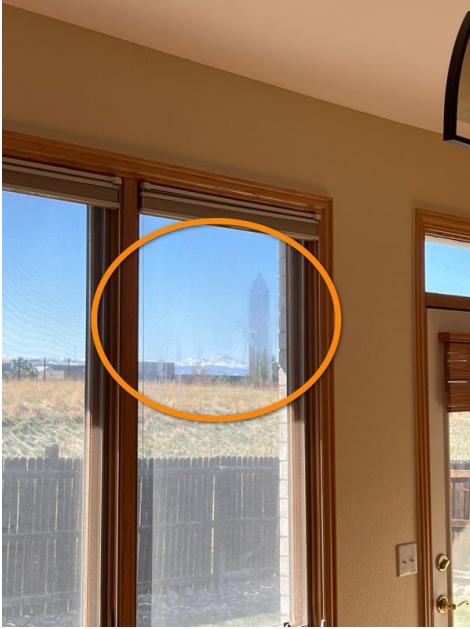
12.9.1 Windows

FAILED THERMAL SEALS

Stains and failed bitumen seals noted between some window panes. Thermal seals are likely broken. Thermal seal failures are typically a cosmetic concern with only a minor impact on energy efficiency, but they can be expensive to replace. Have a window specialist inspect this entire window system to determine all seal failures in the home and repair/replace individual units as necessary for best function.

Contact a qualified window repair/installation contractor.

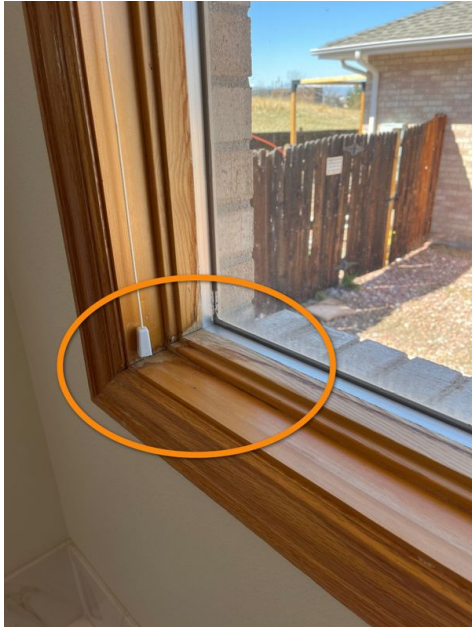
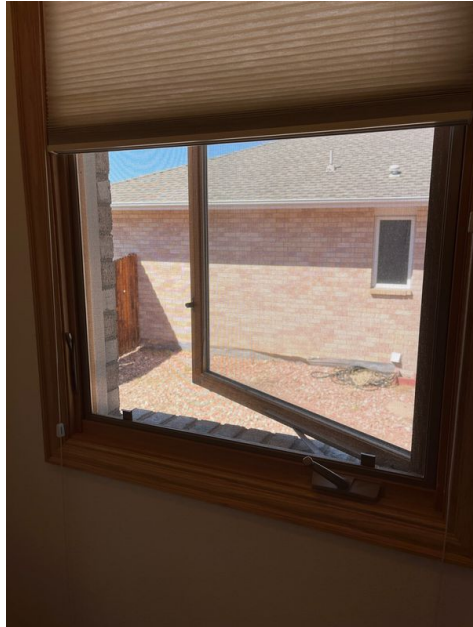
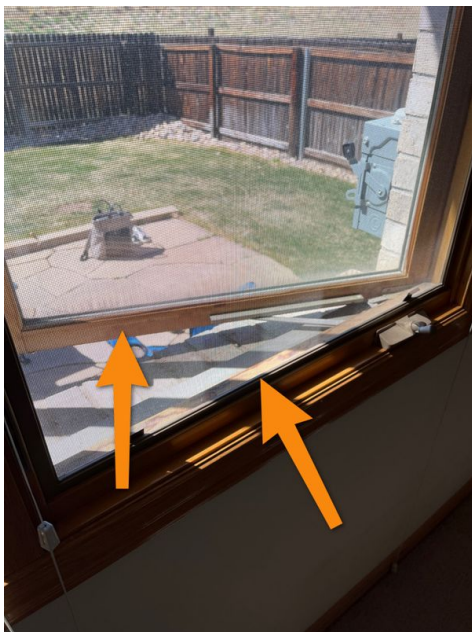
12.9.2 Windows

Wood windows are prone to deterioration. Treat/seal wood windows throughout the house to help prolong the life of the window system.

Contact a qualified window repair/installation contractor.

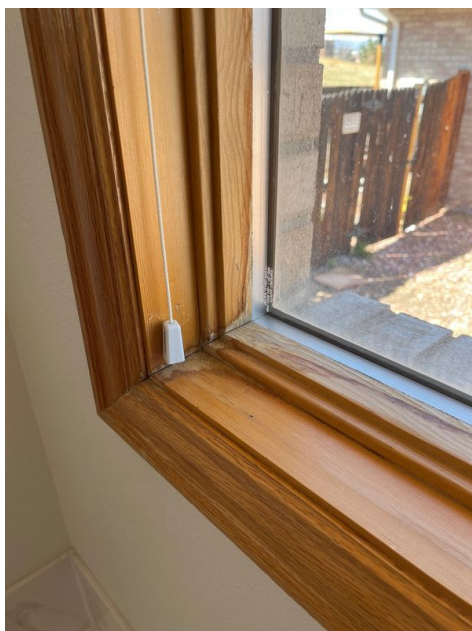
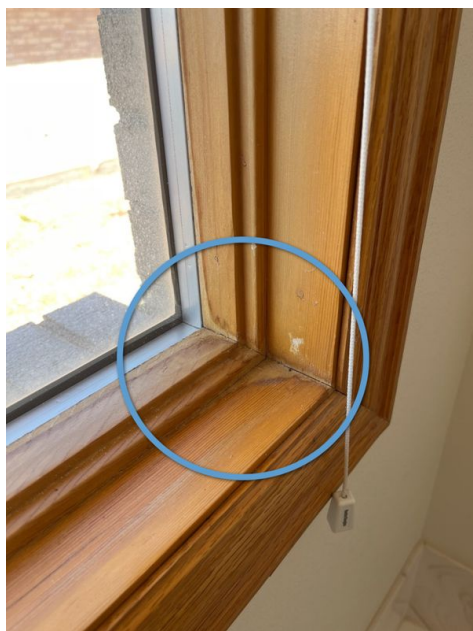
WOOD FRAME DETERIORATION

General deterioration noted to interior wood frames. Recommend re-stain/seal as necessary for improve longevity.

Contact a qualified professional.

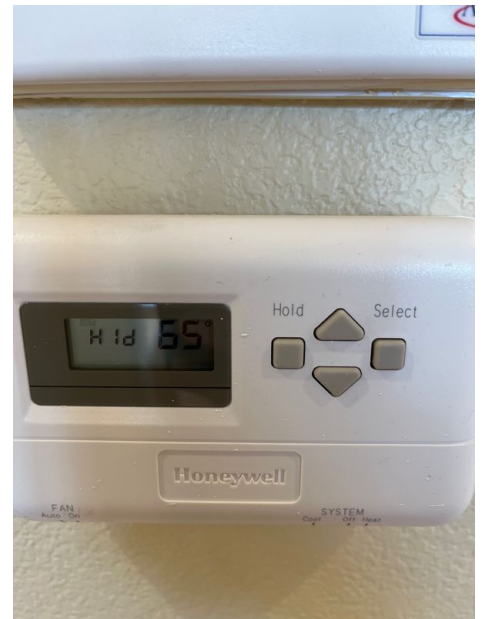
Photo of Thermostat When Leaving

Heat, 65°
